PRE-RENOVATION SURVEY
FOR
ASBESTOS-CONTAINING MATERIALS, LEAD PAINT,
POLYCHLORINATED BIPHENYLS IN CAULK/SEALANTS
AT
600 RIDGE ROAD
WEBSTER, NEW YORK 14580

December 2022

Watts
Architects
& Engineers

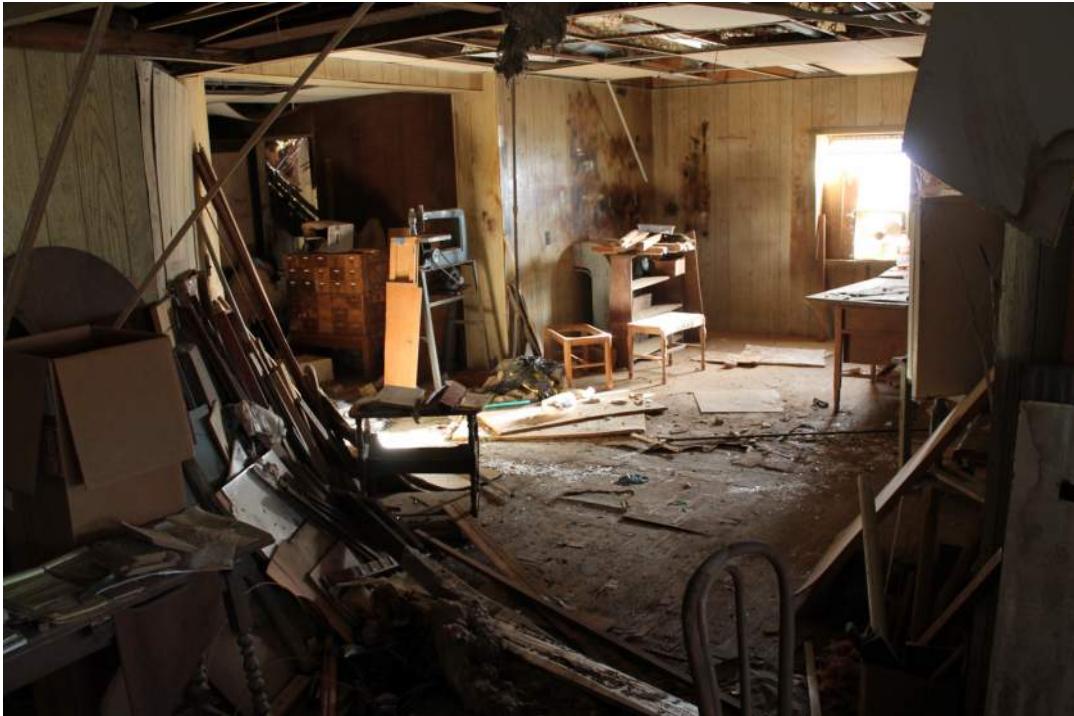
The building at 600 Ridge Rd. is a former furniture repair shop named Webster Furniture Strippers. The original construction date is unknown, but presumed to be in the 1940's. The building is constructed of concrete, brick, and wood with an asphalt shingle/rolled roof system. The building may have been heated with a small boiler due to abandoned piping in the basement. A furnace was observed in the basement but was not active. The main structure is unoccupied and in poor condition. Several areas of the roof collapsed into the building and some of the wall finishes have completely deteriorated leaving exposed wall studs. Water damaged building materials were observed throughout the first floor.

Photo 1 – First floor overview. Note deteriorated site conditions present.

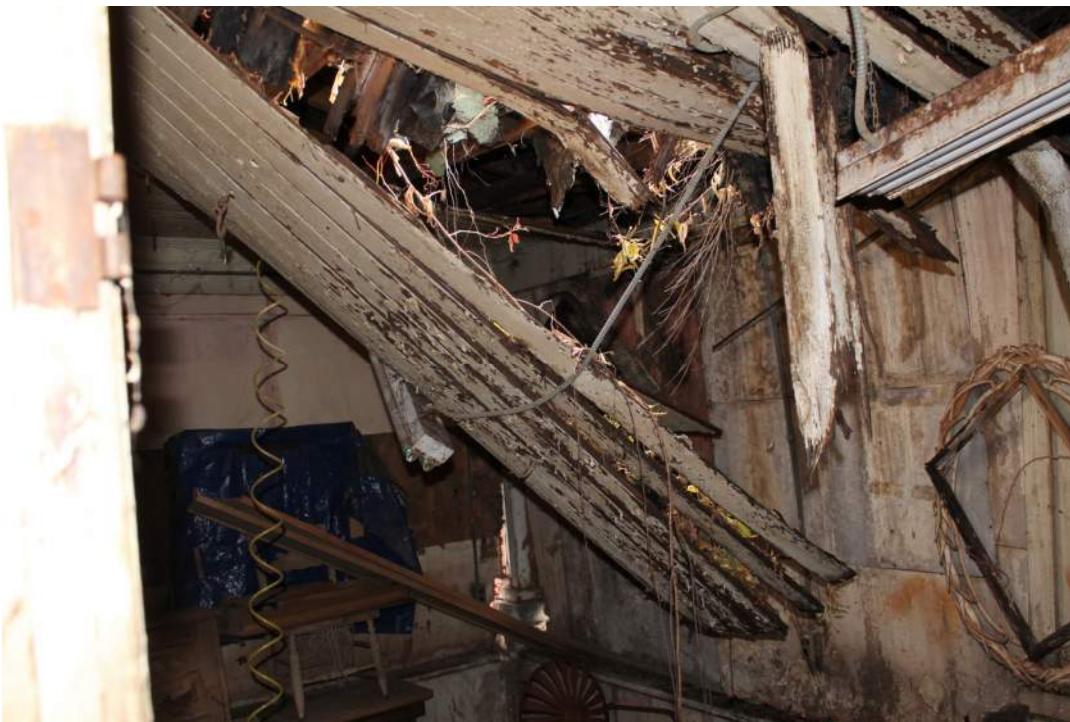
There is potential of the building being structurally condemned by a professional engineer due to deteriorated conditions. If the building is condemned, this will affect the procedures used for asbestos abatement.

Photo 2 – First floor ceiling collapse in the back of the first floor.

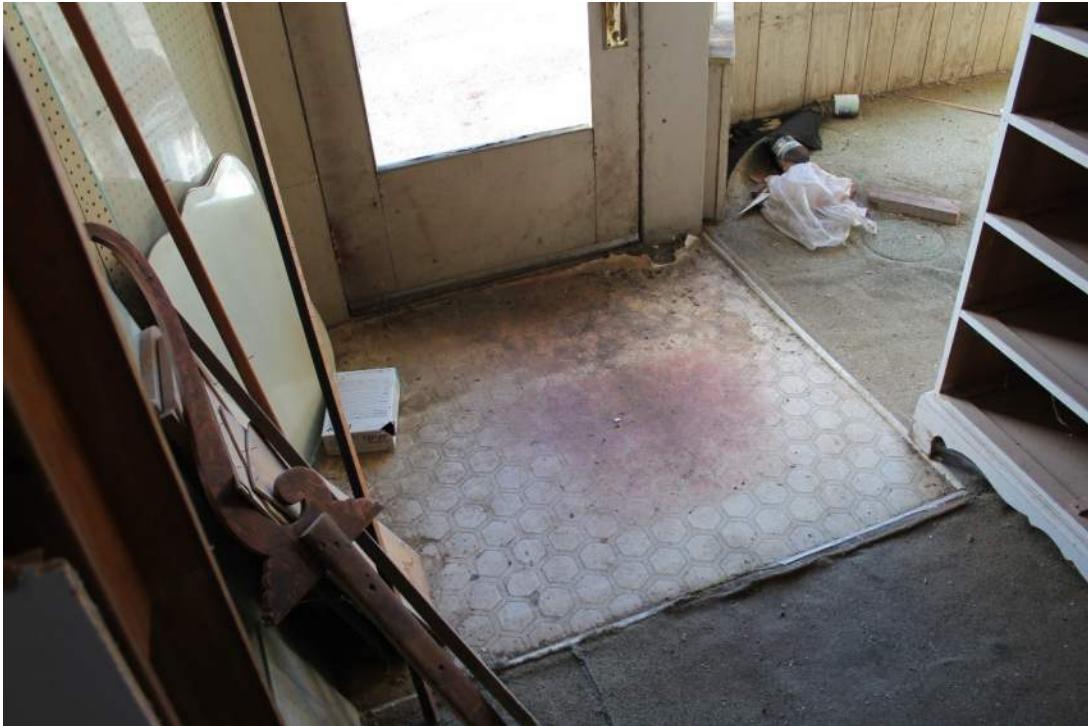
- **Sheet vinyl flooring.** Non-friable sheet vinyl flooring has been identified at the main entrance into the building. The sheet vinyl identified is in fair condition. Approximately 20 SF of sheet vinyl has been identified.

Photo 3 – View of asbestos-containing sheet vinyl floor at entry.
9 x 9 floor tile located below sheet vinyl.

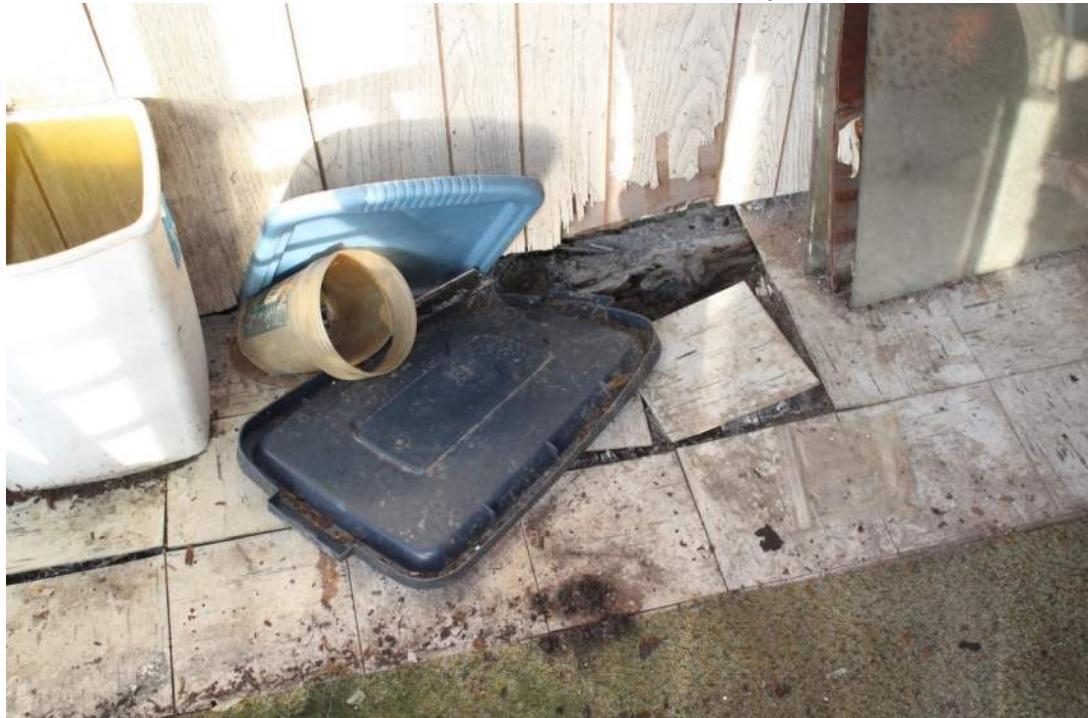
- **White 9 x 9 floor tile and associated black mastic.** Non-friable floor tile and associated mastic has been identified under the asbestos-containing sheet

vinyl at the main entrance and scattered locations throughout the first floor. The floor tile and associated mastic are in good condition. Approximately 900 SF of floor tile and associated mastic has been identified throughout the first floor.

Photo 4 – View of asbestos-containing 9"x 9" white floor tile and associated black floor tile mastic on the first floor.

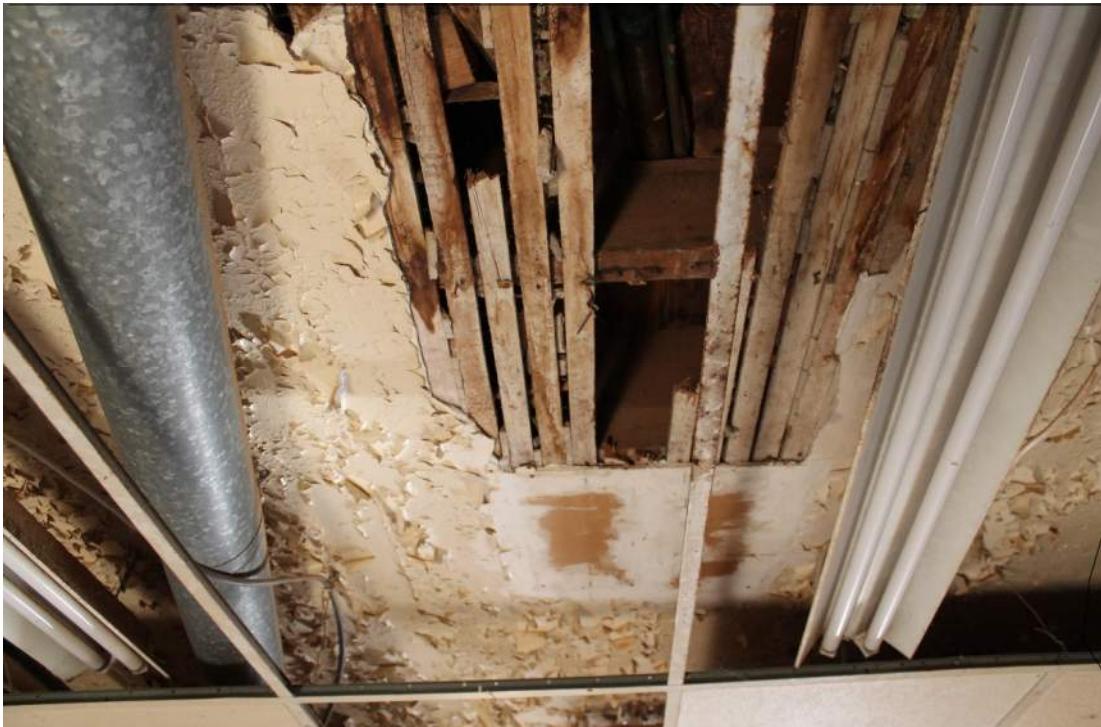
- **Ceiling plaster skim coat.** Non-friable skim coat ceiling plaster has been identified on the first-floor workshop area and the second floor stairwell of the main building. The skim coat ceiling plaster is in poor condition. Approximately 900 SF of ceiling plaster skim coat has been identified.

Photo 5 – View of asbestos-containing ceiling plaster skim coat on the first floor workshop area.

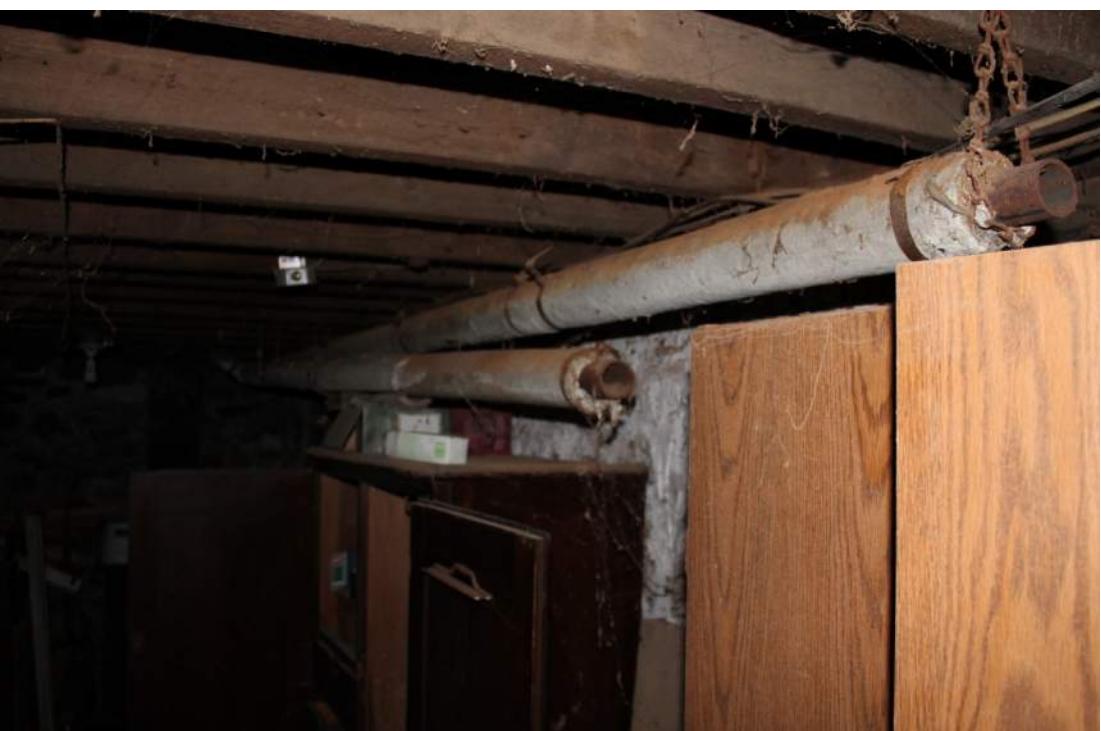
- **Pipe insulation.** Friable pipe insulation has been identified in the basement. The insulation identified is in fair condition. Pipe insulation is assumed present in wall cavities on the first floor. Approximately 115 LF of pipe insulation is located in the basement. 140 LF of pipe insulation is assumed present in wall cavities.

Photo 6 – View of asbestos-containing pipe insulation in the basement. Assumed present in wall cavities on the first floor.

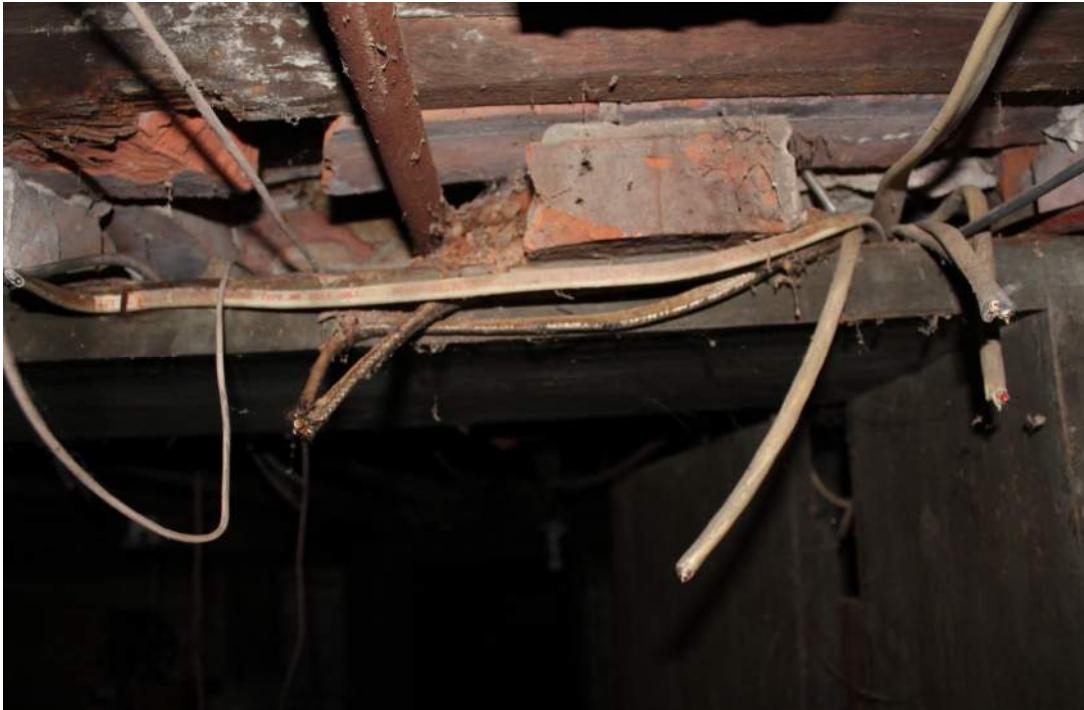
- **Wire insulation.** Suspect asbestos containing cloth and braided wire insulation was located in the basement and assumed present within the walls on the first and second floor. It could not be determined if these wires were still energized, therefore sampling could not be performed. All cloth and braided wire insulation shall be assumed to be asbestos containing. Approximately 300 LF or 6 SF of wire insulation is assumed present.
- **Roofing materials (fields, flashing, cements, caulk).** The roof collapsed in several locations and was determined to be unsafe for sample collection and at the time of inspection. All roofing materials shall be assumed to contain asbestos until safe access to the roof can be provided. Approximately 5,000 SF of roofing materials are present on the main building and 1,110 SF of roofing materials are present on garage.

Photo 7 – View of assumed asbestos-containing braided wire insulation in the basement.

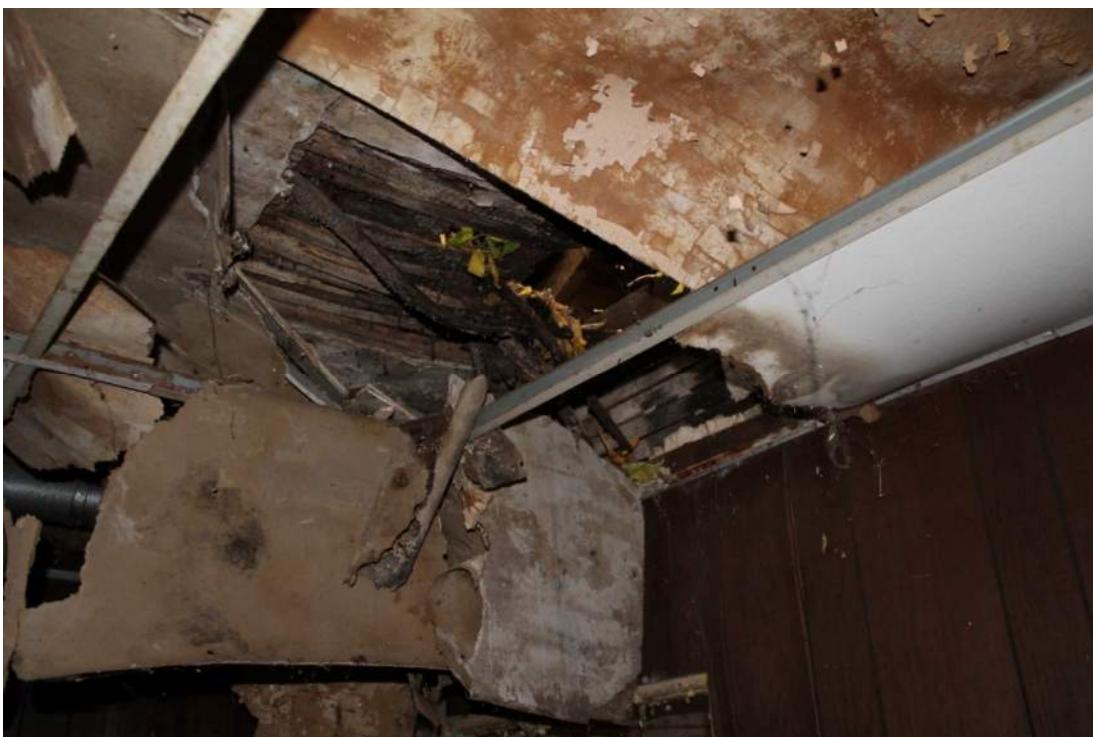
- **Wall panel mastic.** Non-friable wall panel mastic has been identified on the first floor in the back workshop area. The mastic identified is in good condition. Approximately 416 SF of wall panel mastic was identified.

Photo 8 – View of wall panels with asbestos-containing mastic on the first floor.
Note: Dangerous site conditions, ceiling collapsed.

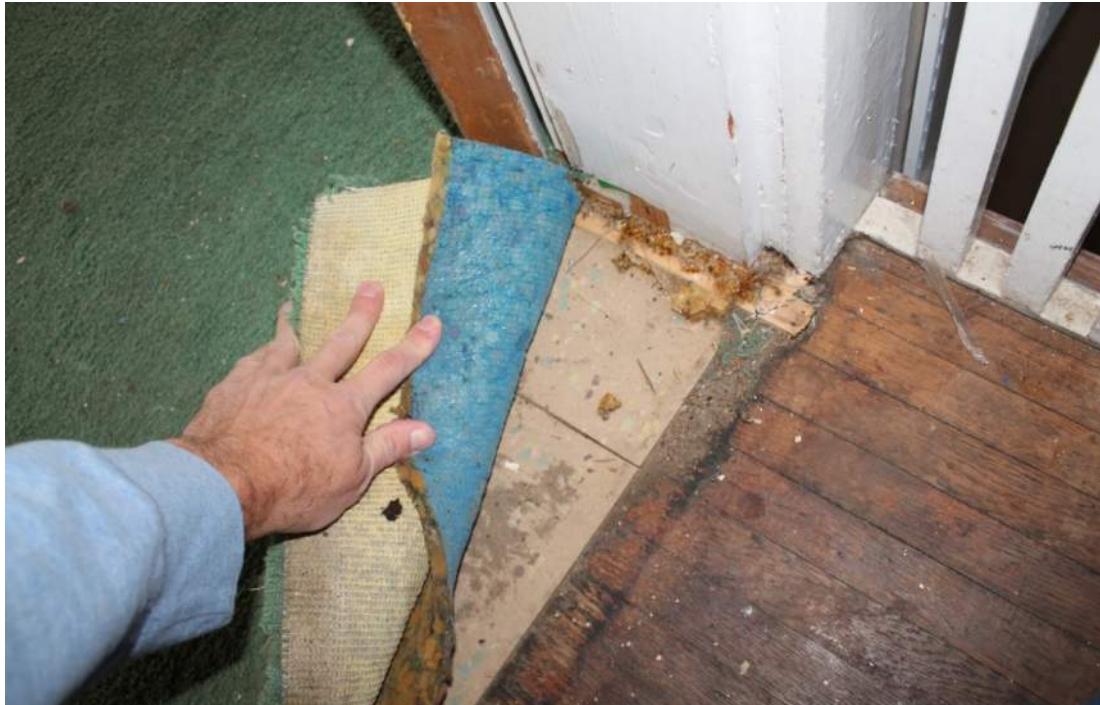
- **Tan/pink/blue 9 x 9 floor tile and associated black mastic.** Non-friable floor tile and associated mastic has been identified on the second floor in the living room under the carpet. The floor tile and associated mastic are in good condition. Approximately 250 SF of floor tile and associated mastic has been identified.

Photo 9 – View of asbestos containing 9 x 9 pink floor tile and associated black floor tile mastic under carpet in the second-floor apartment.

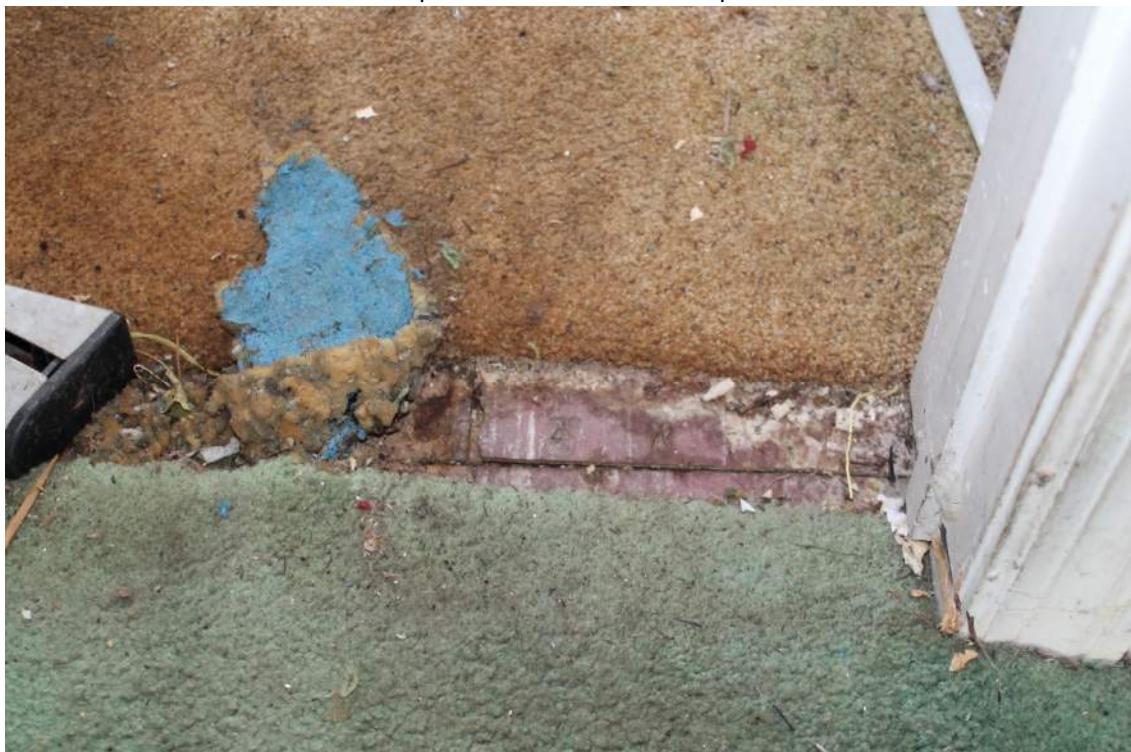
- **Maroon 9 x 9 floor tile and associated black mastic.** Non-friable floor tile and associated mastic has been identified on the second floor in the closet, small bedroom and large bedroom under the carpet. The floor tile and associated mastic are in good condition. Approximately 362 SF of floor tile and associated mastic has been identified.

Photo 10 – View of asbestos containing 9 x 9 maroon floor tile and associated black floor tile mastic under carpet in the second-floor apartment.

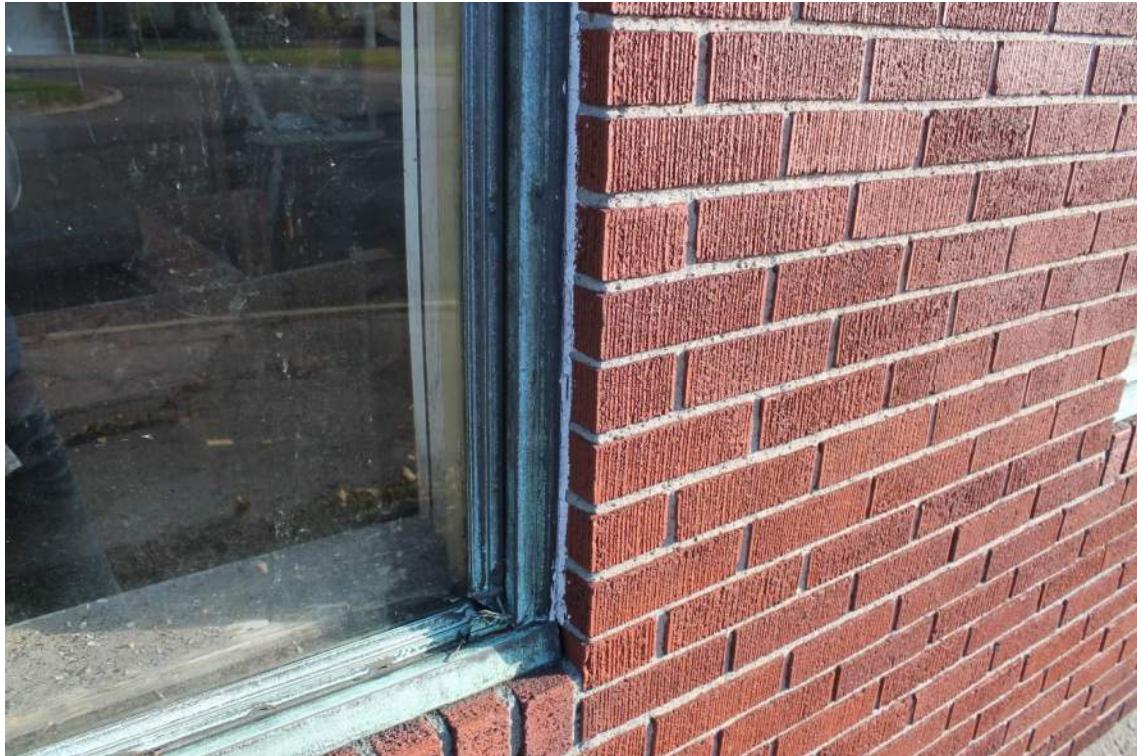
- **Window caulk.** Non-friable window caulk has been identified on the storefront windows at the front entrance of the building between the copper window frame and brick. The window caulk is in good condition. Approximately 2 SF of window caulk has been identified.

Photo 11 – View of asbestos containing window caulk copper frame to brick on the exterior storefront windows.

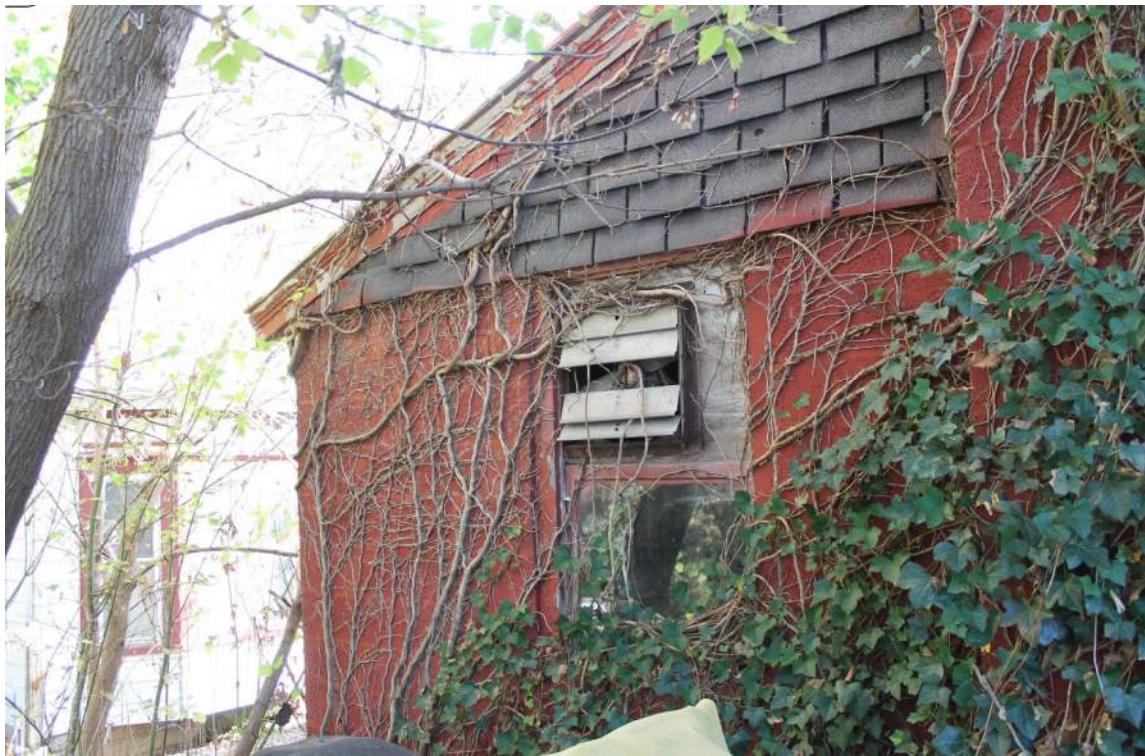
- **Window glazing compound.** Non-friable window glazing compound has been identified on the exterior garage window. The window glazing compound is in good condition. Approximately one window containing 1 SF of window glazing compound has been identified.

Photo 12 – View of asbestos containing window glazing compound on exterior garage window.

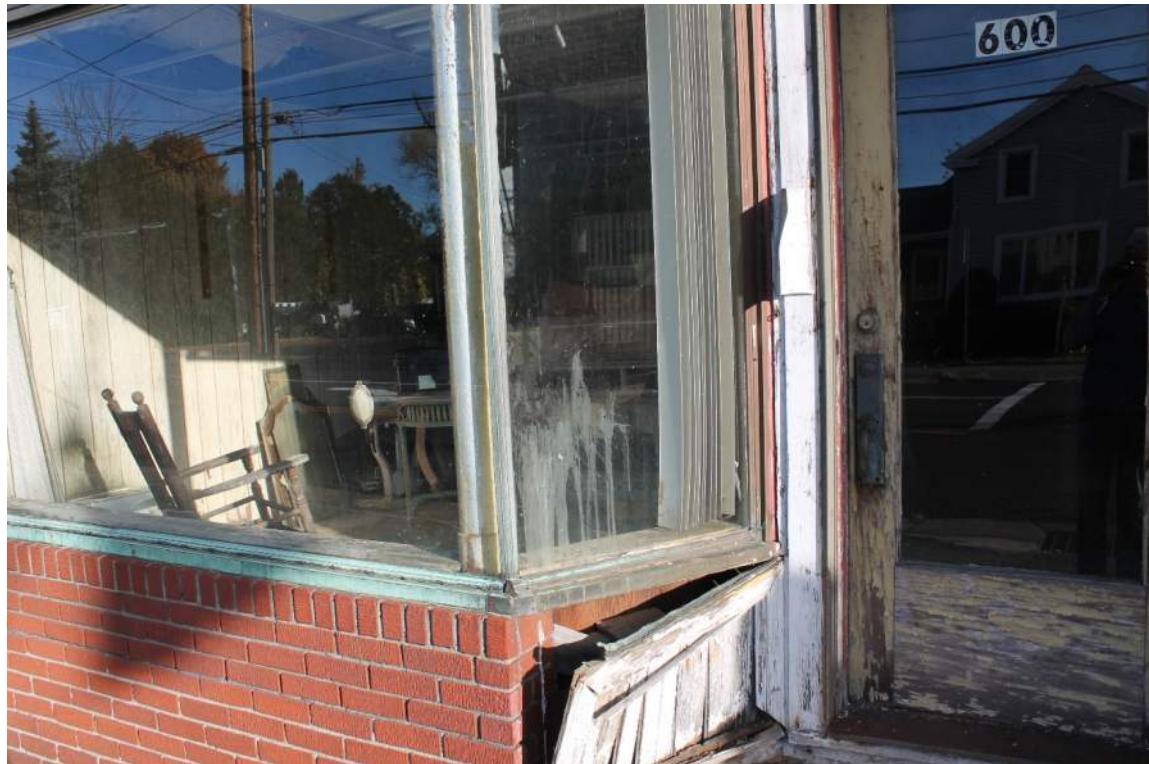
- **Window caulk.** Non-friable window caulk was identified on the copper window frame of the storefront windows. The window caulk is in poor condition. Approximately one window containing 1 SF of window glazing compound has been identified.

Photo 13 – View of asbestos containing window caulk on the copper window frame on the storefront windows, front of building.
