# 600 Ridge Road

Past, Present, & Future

# Phase II Environmental Site Assessment & Structural Report

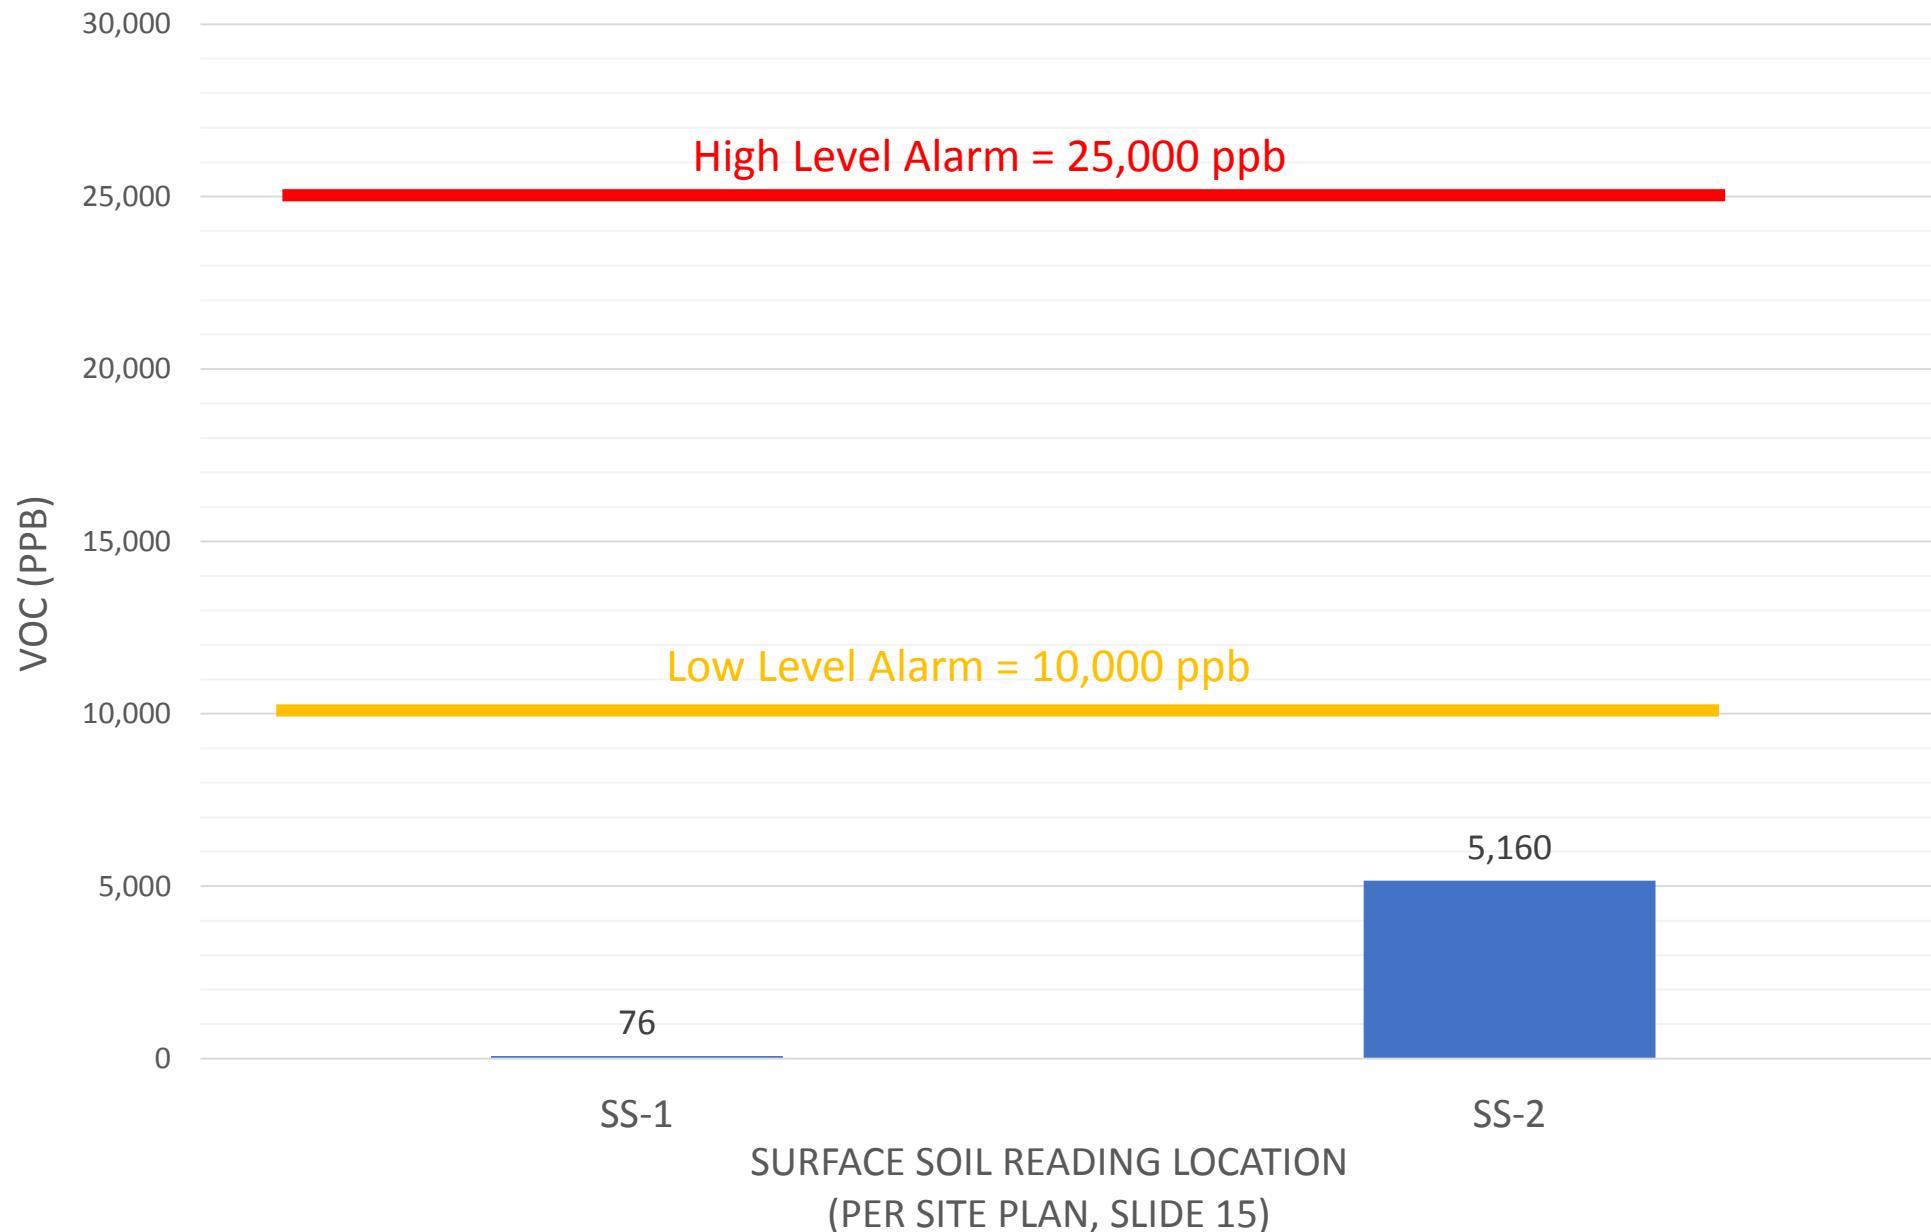
## Ground Surface VOC Readings

- Main Building Basement – No evidence of contaminants
- Exterior:
  - a. SS-1 (*between Main Building and Garage*): VOC's ranged from 0 – 76 ppb
  - b. SS-2 (*north of Garage*): VOC's ranged from 29 - 5,160 ppb

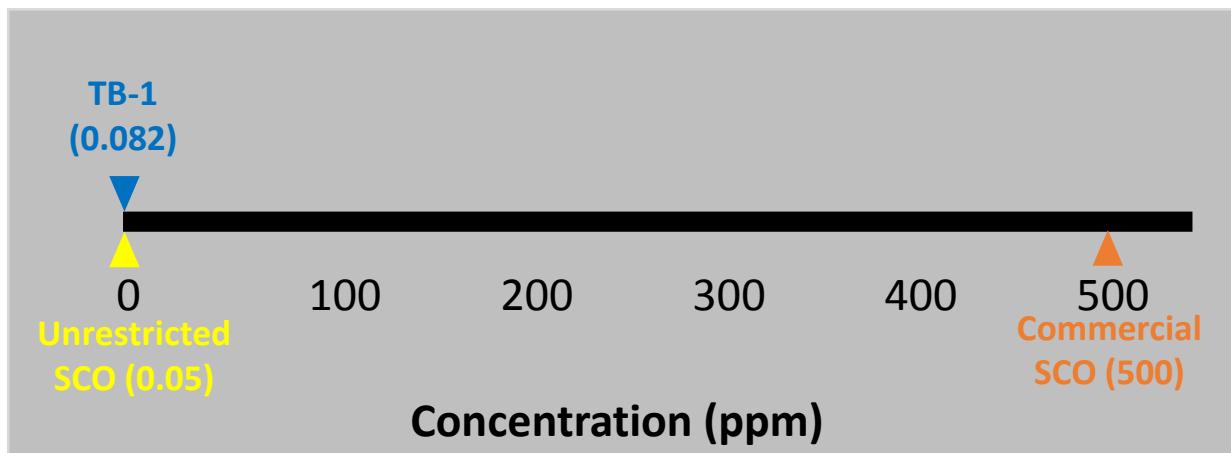
- VOC – Volatile Organic Compounds  
*organic chemical compounds which can evaporate under normal indoor atmospheric temperature and pressure ex: vapors from gasoline, paints, glues*
- One Sample, from inside garage, detected methylene chloride at a depth of 3-4ft exceeding the Unrestricted SCO.

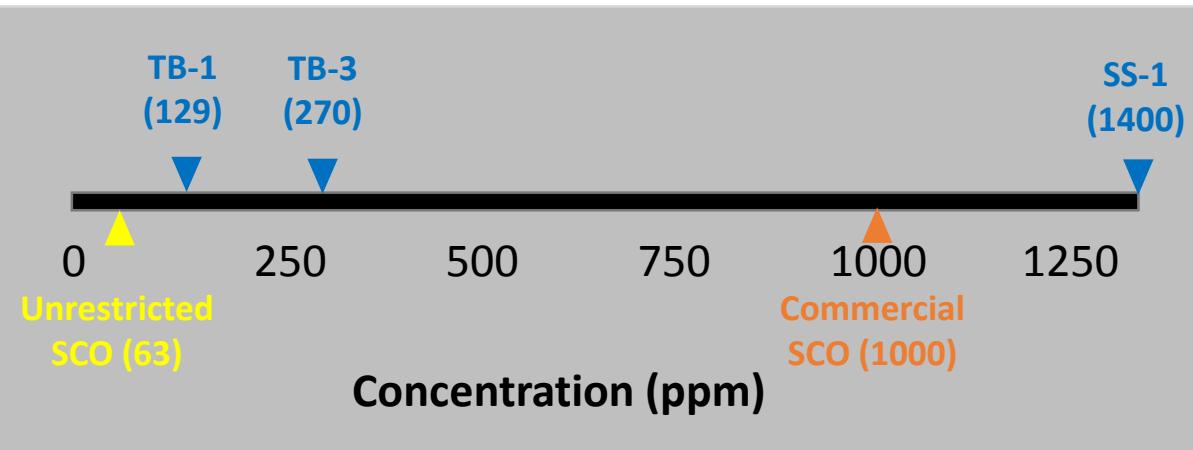
**Lead** – Three samples detected elevated levels.

- Two exceeded “Unrestricted SCO” (63ppm) – *(TB-1 at 4-6ft depth // TB-4 at 2-4ft depth)*
- One exceeded “Commercial SCO” (1000ppm) – *SS-1 at 0-6in depth*

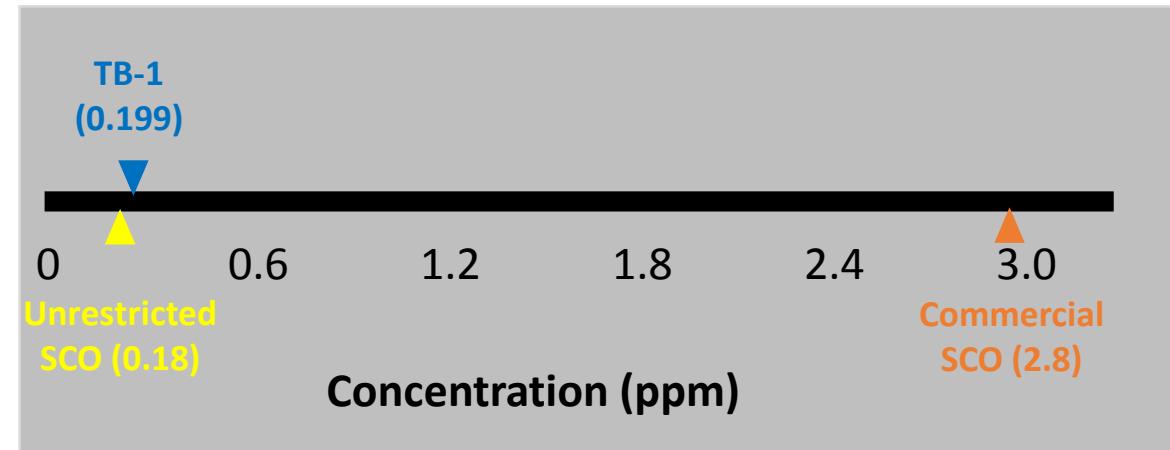
**Mercury** – One sample detected elevated level.

- Depth of 6ft or less
- Exceeded only “Unrestricted SCO” concentration

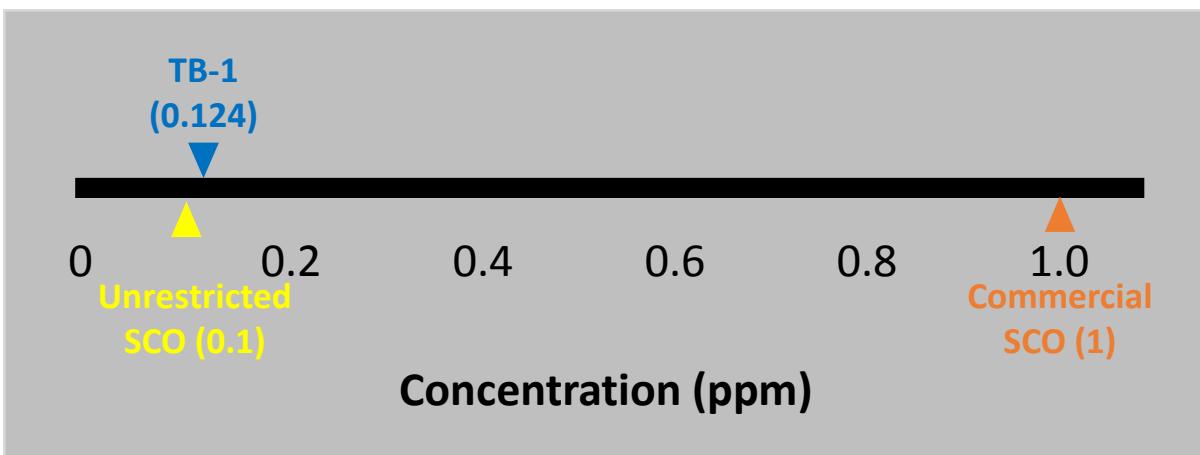
- PCB – Polychlorinated Biphenyls  
(*man made organic chemicals banned in 1979 such as Teflon*)
- One Sample, from inside garage, tested positive for PCB's at a depth of 4-6ft.

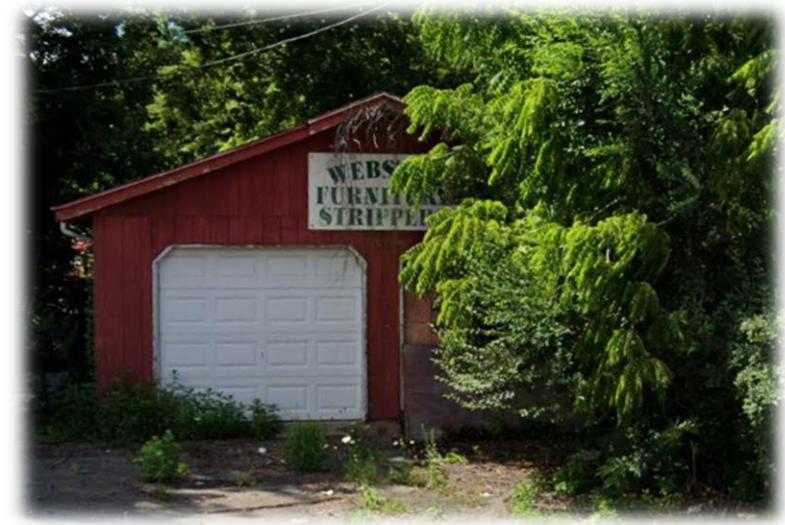
- A. One sample taken under building basement slab – **No constituents detected** at concentrations greater than Air Guidance and/or 90<sup>th</sup> percentile of NYS Department Of Health Guidance (NYSDOH)
- B. Two samples taken under garage floor:
  - Six constituents detected at concentrations greater than Air Guidance and/or 90<sup>th</sup> percentile of NYSDOH:
    - Methylene Chloride (*paint stripper*)
    - Acetone (*paint remover*)
    - Carbon Disulfide (*softens paints and varnishes*)
    - Chloroform (*solvent for lacquers, polish, & resin*)
    - Hexane (*solvent & cleaning agent*)
    - Toluene (*manufacturing of paints & lacquers*)

- Installation of vapor mitigation systems (similar to a household radon systems)
- Installation of additional monitoring wells to triangulate groundwater movement.
- Characterization of fill samples
- Additional Materials Testing for asbestos and lead paint
- Developing a remediation and/or Site Mitigation Plan (SMP)

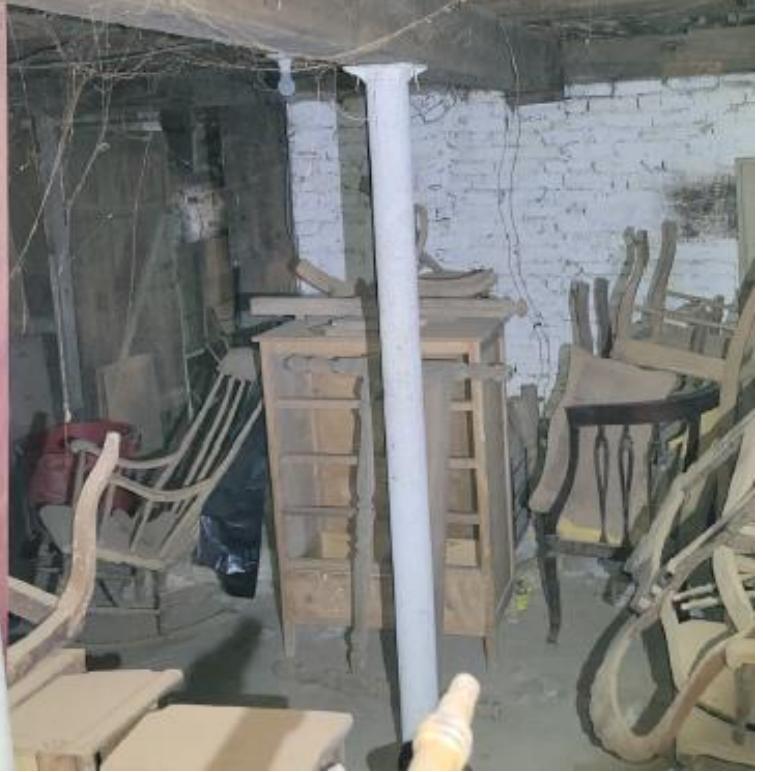
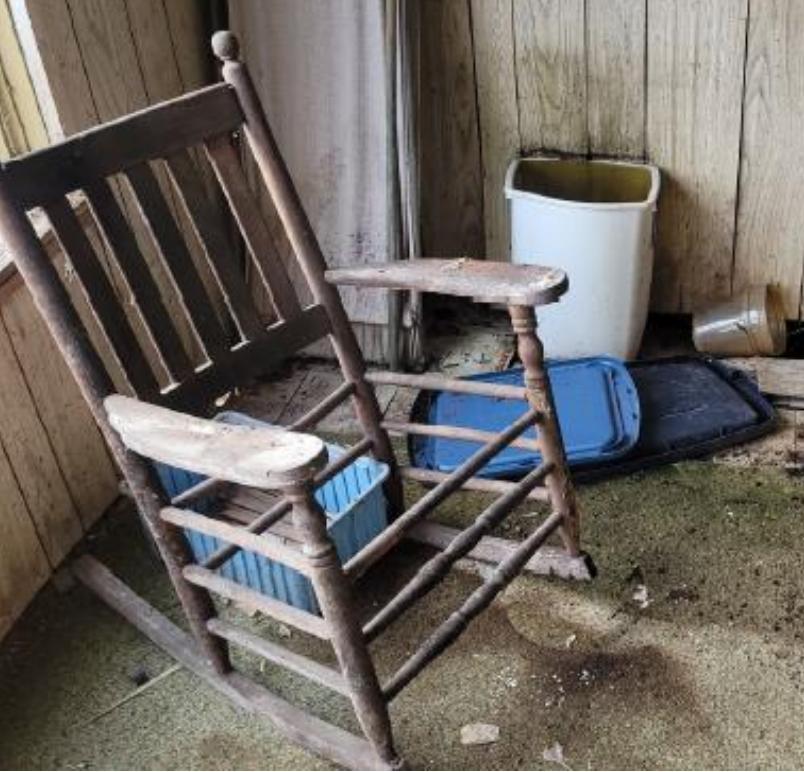
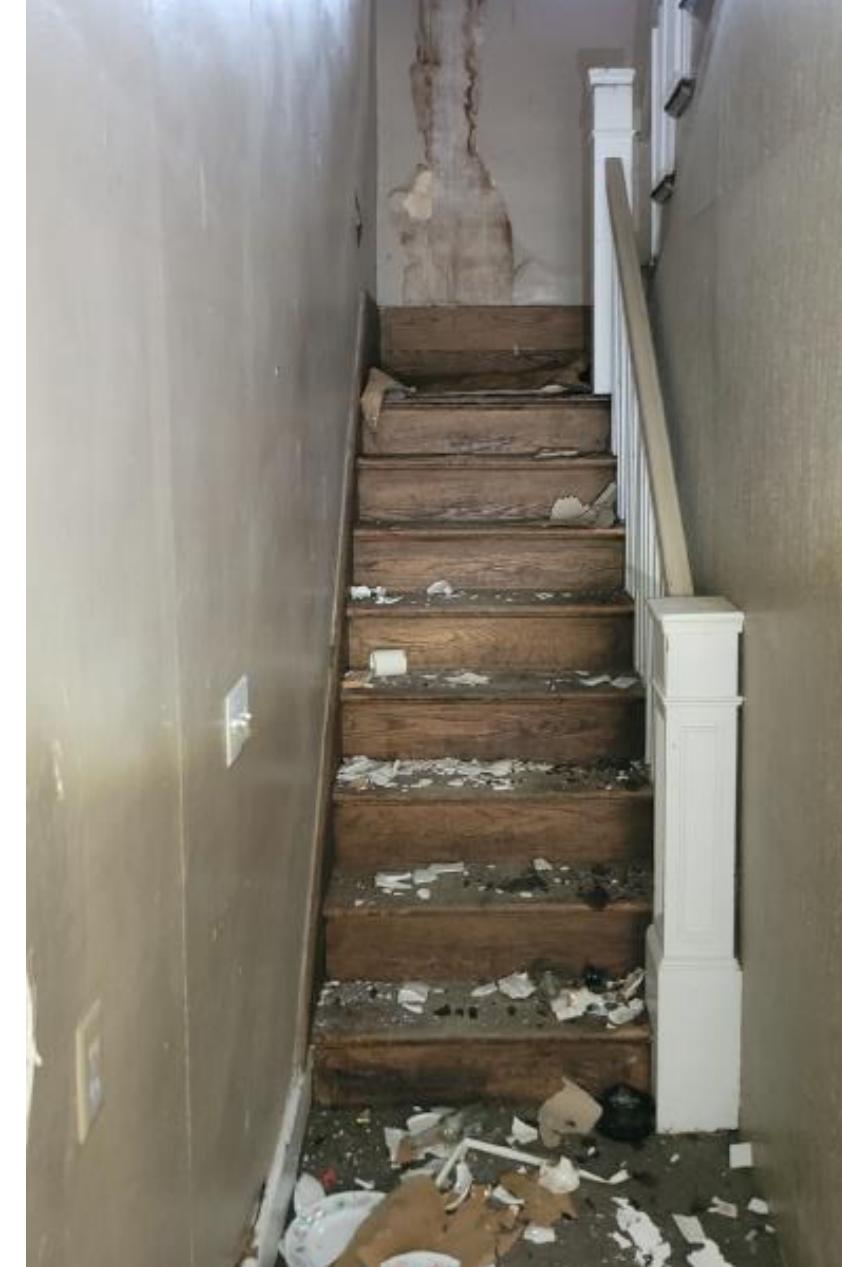
- Materials in the building were tested for:
  - ✓ **Asbestos** – Much of the pipe insulation, flooring, mastics, glazings, and caulk were found to contain asbestos.
  - ✓ **Lead-based Paint** – Many painted items tested positive
  - ✓ **PCB's** – No items detected levels exceeding 50ppm, and therefore would not require special handling and disposal.

- A. Main Building**  
Structurally sound. Requires repair and replacement of components but can be salvaged.
- B. Garage**  
Recommended for demolition
