# Structural Assessment Report

600 Ridge Road  
Webster, NY 14580

December 13, 2022

Report Prepared for:  
Town of Webster

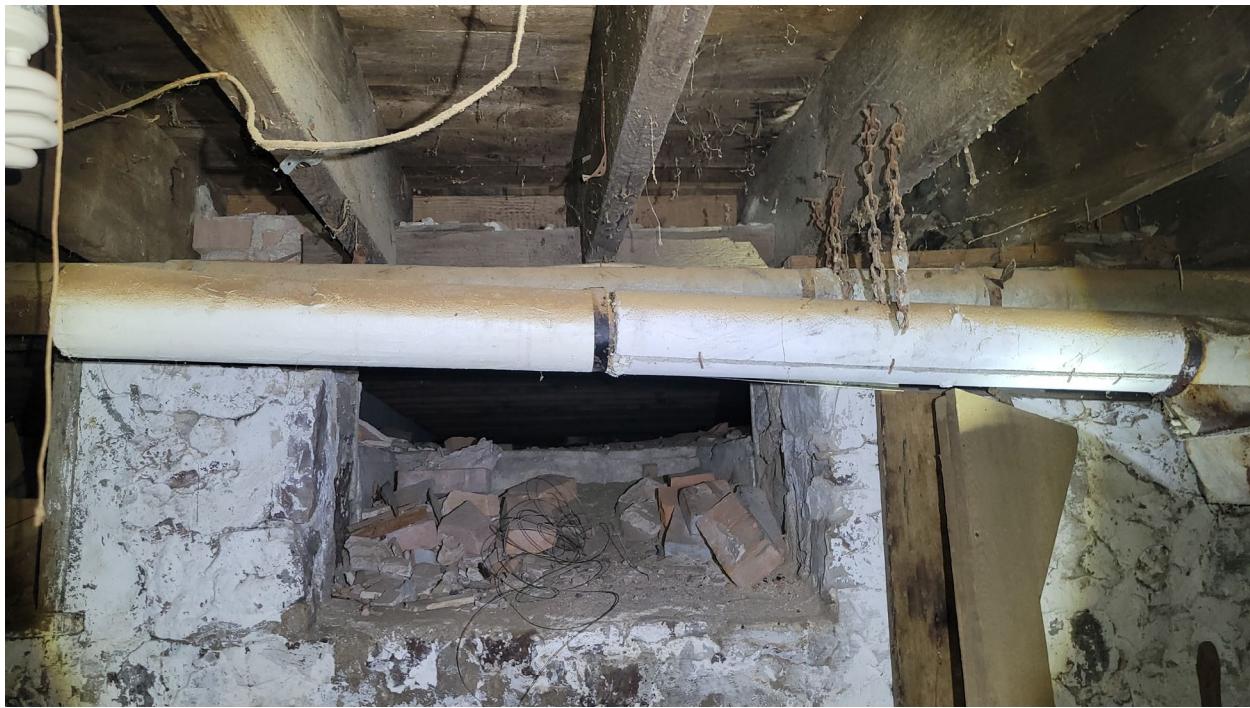
17. Photo 31: Pipe coverings could have asbestos in them. It is recommended to either test the insulation for asbestos, or have removed by an asbestos remediation professional.

*Photo 31: Pipe coverings could have asbestos in them. It is recommended to either test the insulation for asbestos, or have removed by an asbestos remediation professional.*

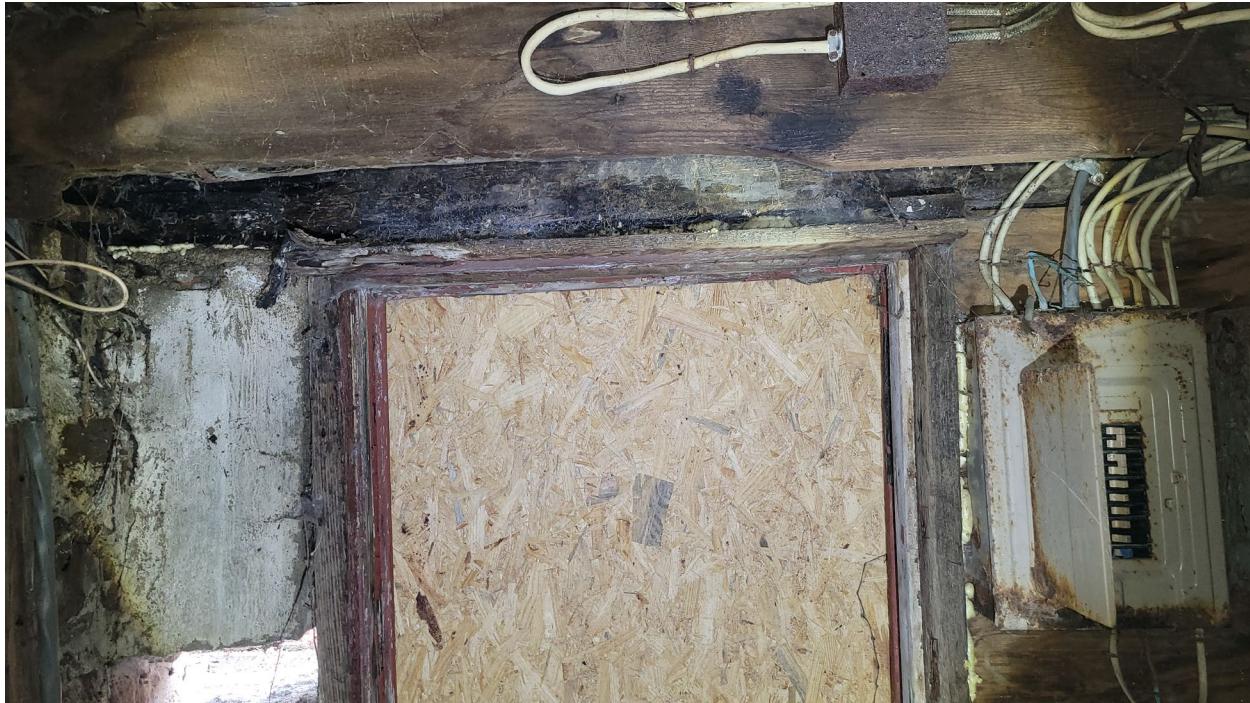
*Photo 57: Area 5, needs extensive repair work done to foundation. See Note 7*

7. Area 5 – The foundation in this area needs to be sealed with new 8" CMU block. It is recommended to shore the existing framing, remove all rotted wood, and replace with new pressure treated lumber. Fully grout all cells of CMU. #5 rebar vertical @ 24" o.c. Truss type reinf. every other course. Total area of replacement is about 80 sq. ft. (if existing footings are exposed and found to be salvageable).

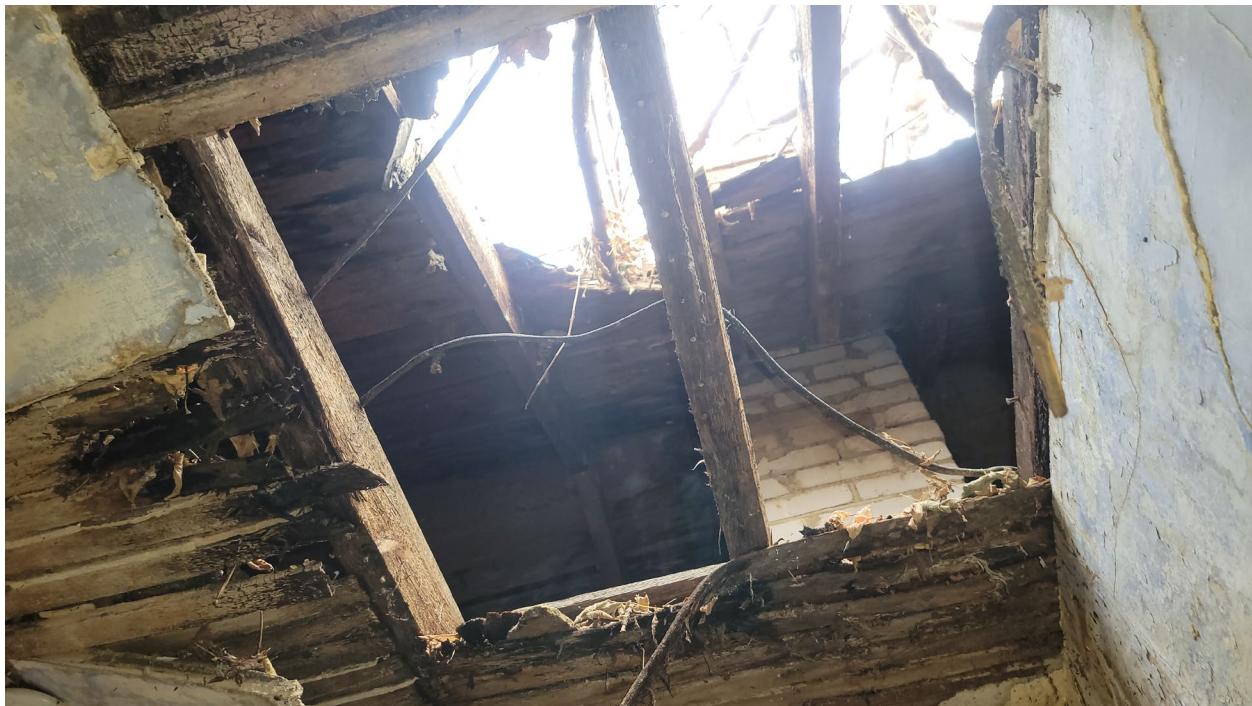
Photo 77: Roof of Area 4 needs to be repaired or replaced.

6. Area 4 – The roof in this area is fully collapsed and needs to be removed and replaced in kind. A-frame roof with 2x10 rafters @ 24" o.c. Rafter ties @ 24" o.c. 2x8 (min). Install Simpson H2.5A Hurricane clips at all rafter end bearing. Total area of replacement is about 250 sq. ft.

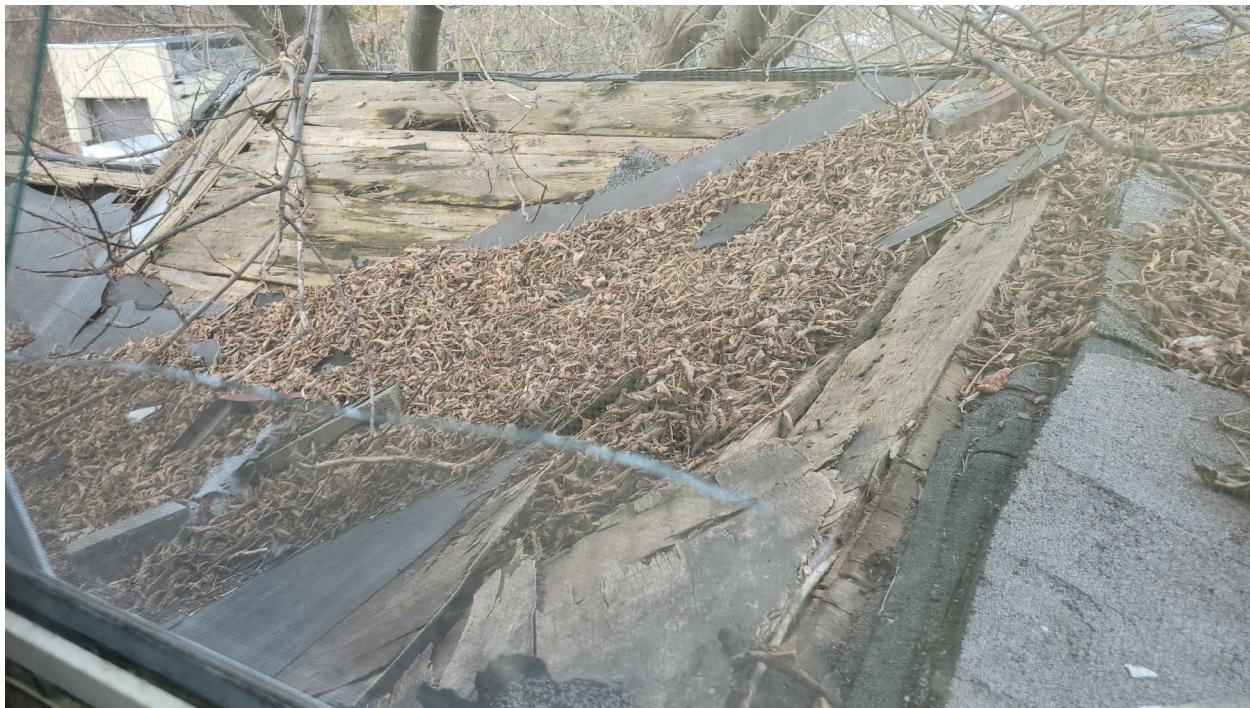
*Photo 120: Roof needs a full tear off and replacement. Existing rafters that are not rotted can be salvaged.*

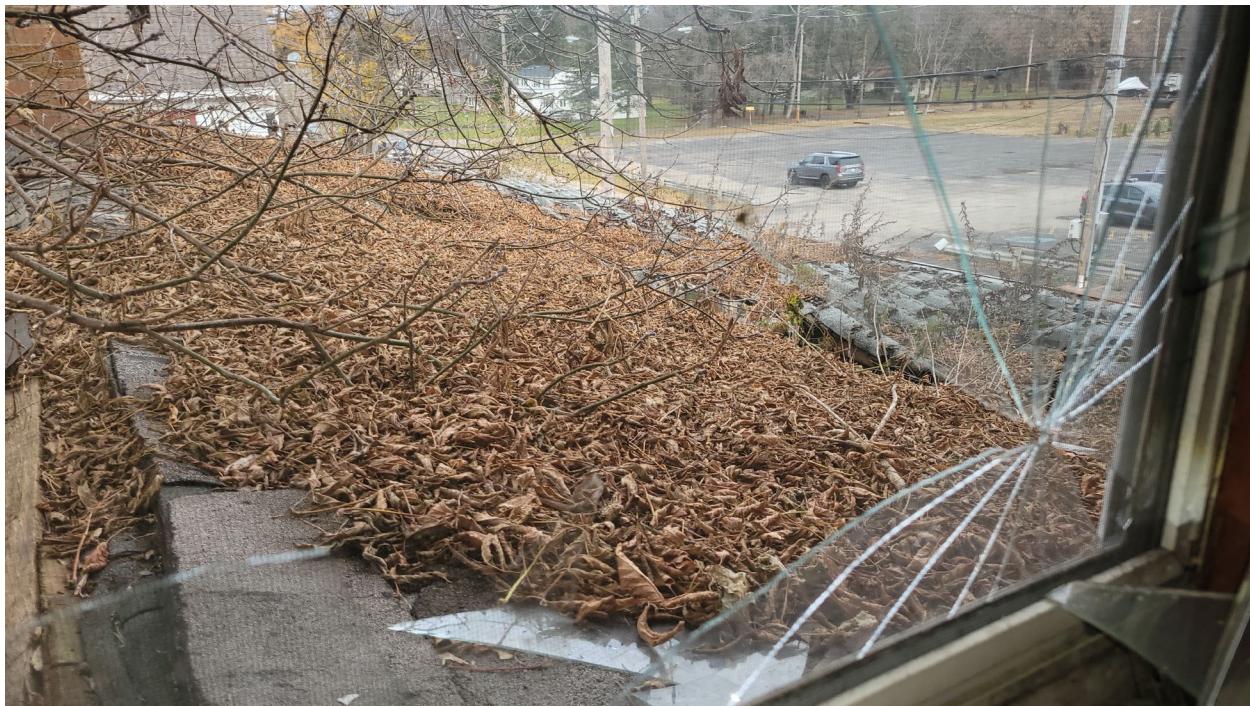
*Photo 121: Area 3 roof.*

5. Area 3 – The roof in this area is fully collapsed and needs to be removed and replaced in kind. A-frame roof with 2x10 rafters @ 24" o.c. Rafter ties @ 24" o.c. 2x8 (min). Install Simpson H2.5A Hurricane clips at all rafter end bearing. Total area of replacement is about 300 sq. ft.

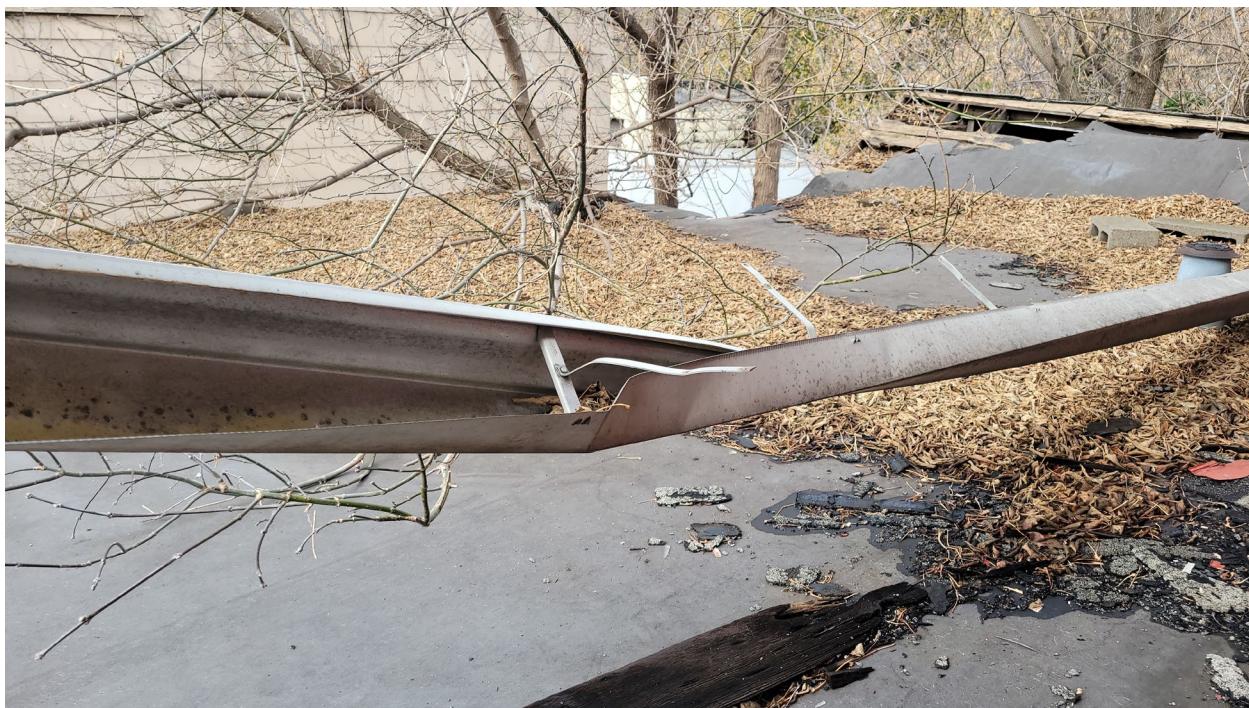
*Photo 140: Area 4 roof.*

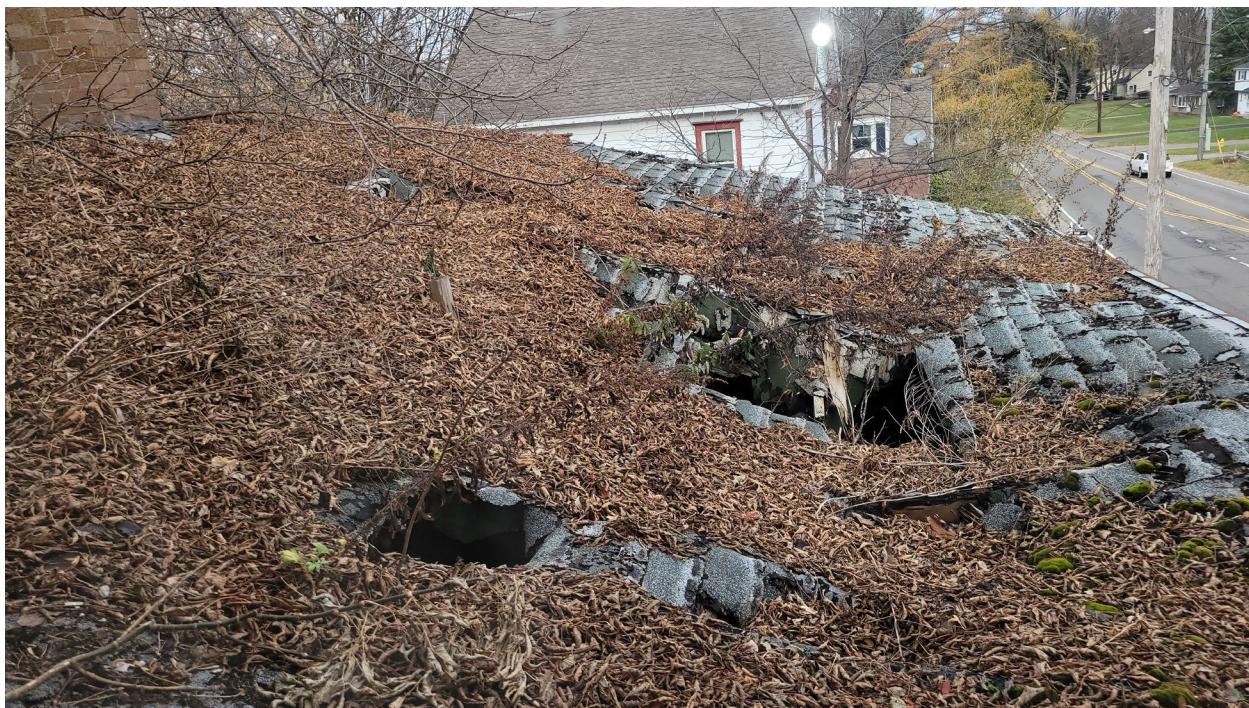
*Photo 142: Area 3 roof.*

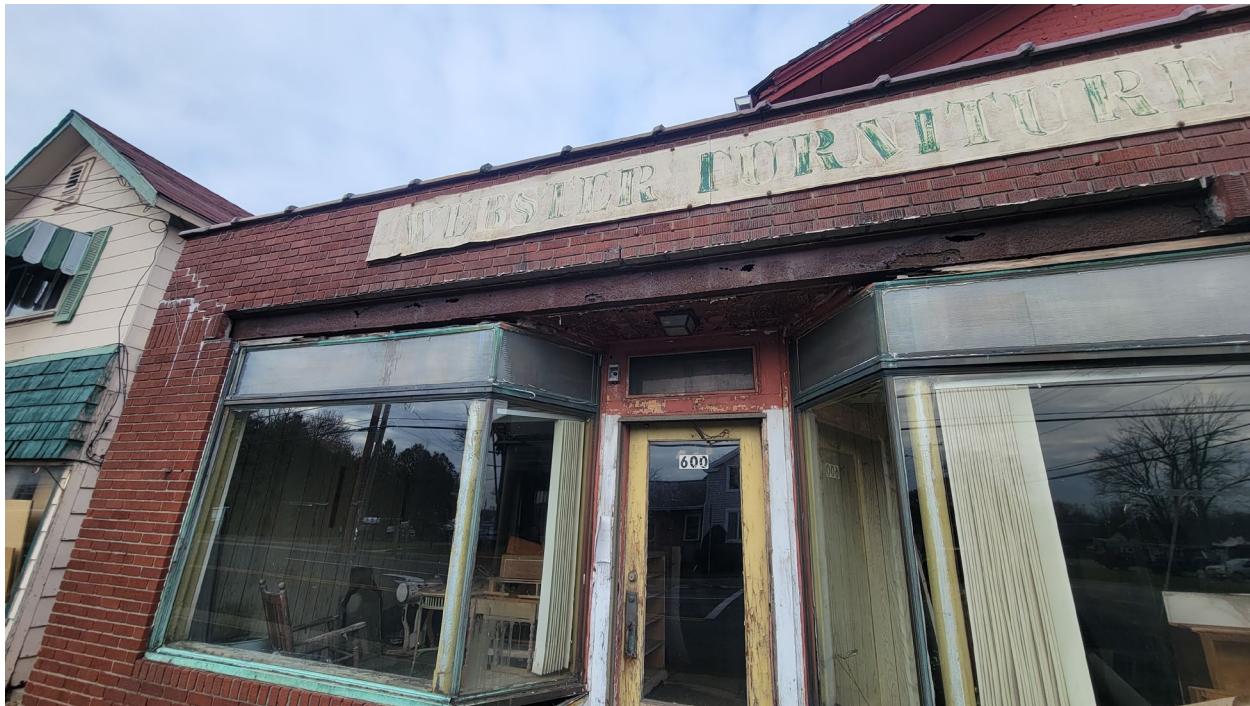
8. The exposed lintel above the main entrance of the building needs to be fully replaced. The web of the steel beam has rotted out and is not salvageable. Replace in kind with same

*Photo 145: Steel lintel needs to be replaced, see note 8.*

depth of steel beam. This beam is load bearing and holding up the brick lintel and roof framing. Shoring will be required for beam replacement.

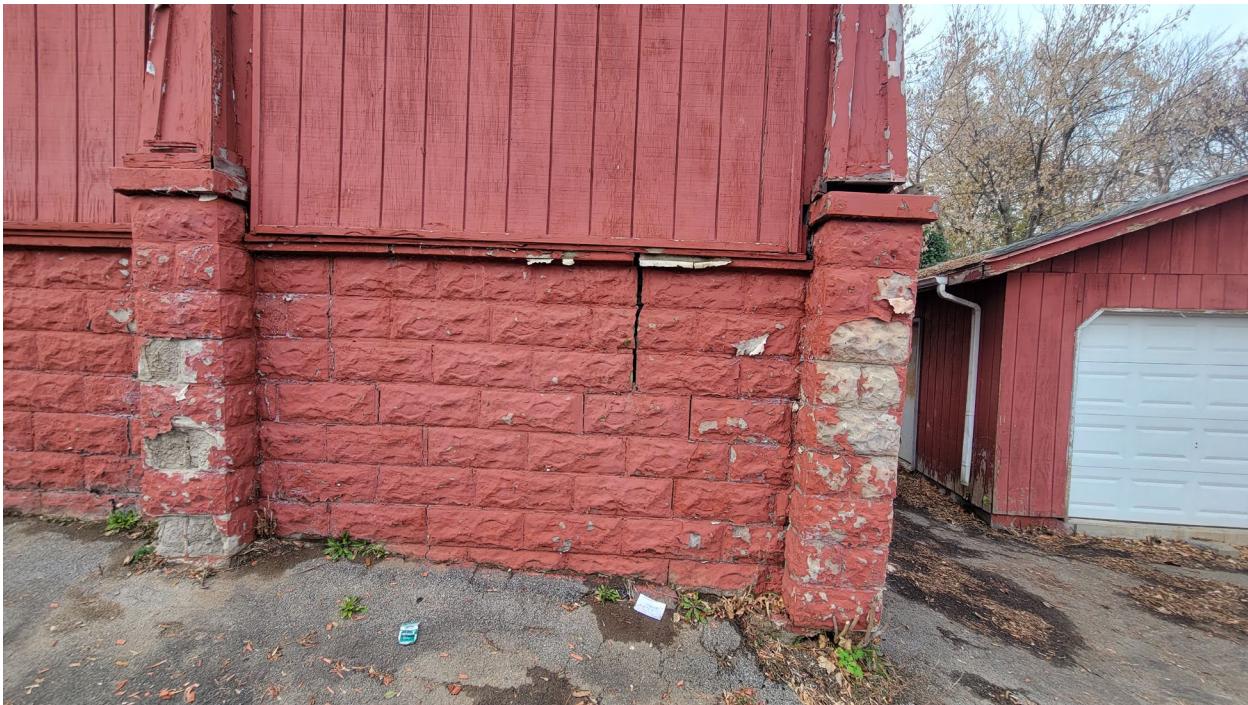
*Photo 168: Evidence of settlement. It is recommended to seal the cracks with a non-shrink grout and then seal the face of the crack lines with an epoxy sealant. Monitor if there is any crack propagation over the next 6 months. If cracks return, contact the Engineer (Grefrath, 716-491-0019) for reinforcement recommendations.*
