**PHASE II ENVIRONMENTAL SITE ASSESSMENT
And
REGULATED BUILDING MATERIALS SURVEY**

**600 Ridge Road
Webster, New York**

Project No.: 5930S-22 / 22-3624S

Date: December 20, 2022
(Revised January 3, 2023 and January 27,
2023)

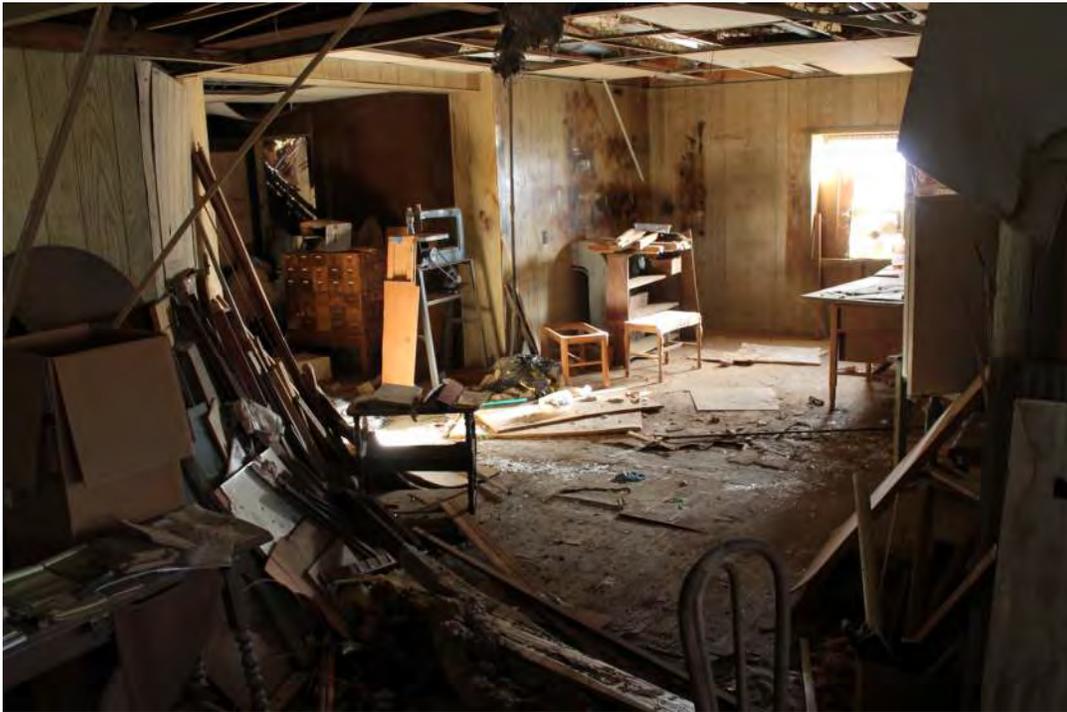
Photo 1 - First floor overview. Note deteriorated site conditions present.

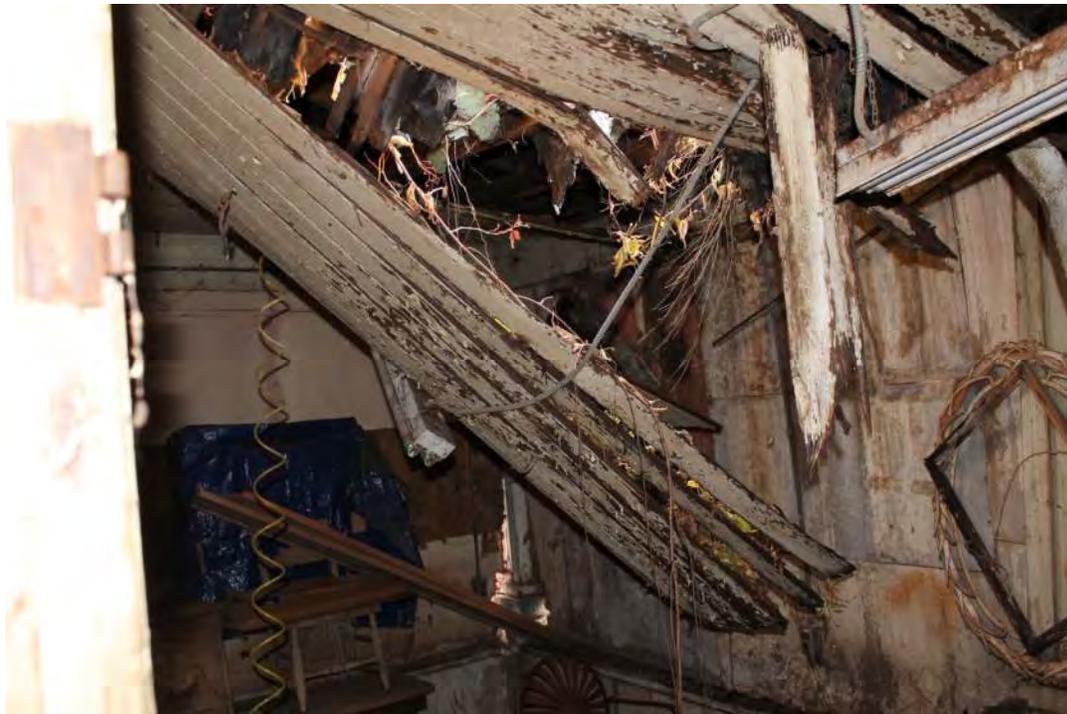
Photo 2 - First floor ceiling collapse in the back of the first floor.

This notice was observed posted on the rear exterior wall of the main building. It stated that the building was posted as "Unsafe". This posting states that the building is unsafe and its use or occupancy is prohibited. This is due to the continuing deterioration of the front façade and collapsing roof in the rear area of the building.

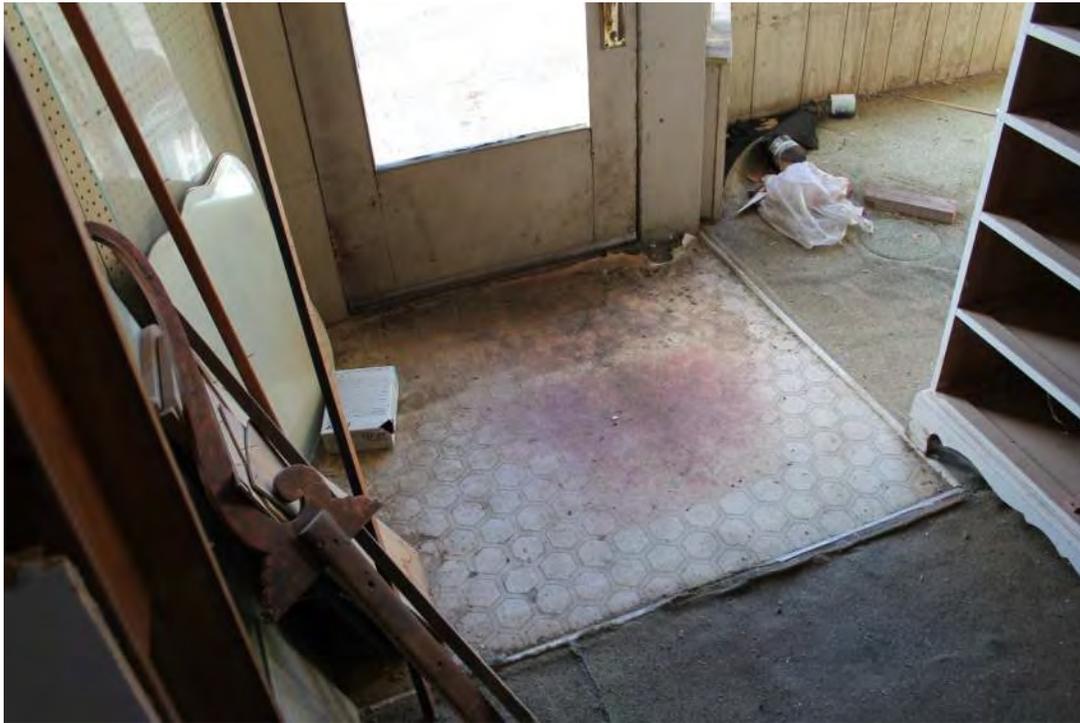
Photo 3 - View of asbestos-containing sheet vinyl floor at entry.
9 x 9 floor tile located below sheet vinyl.

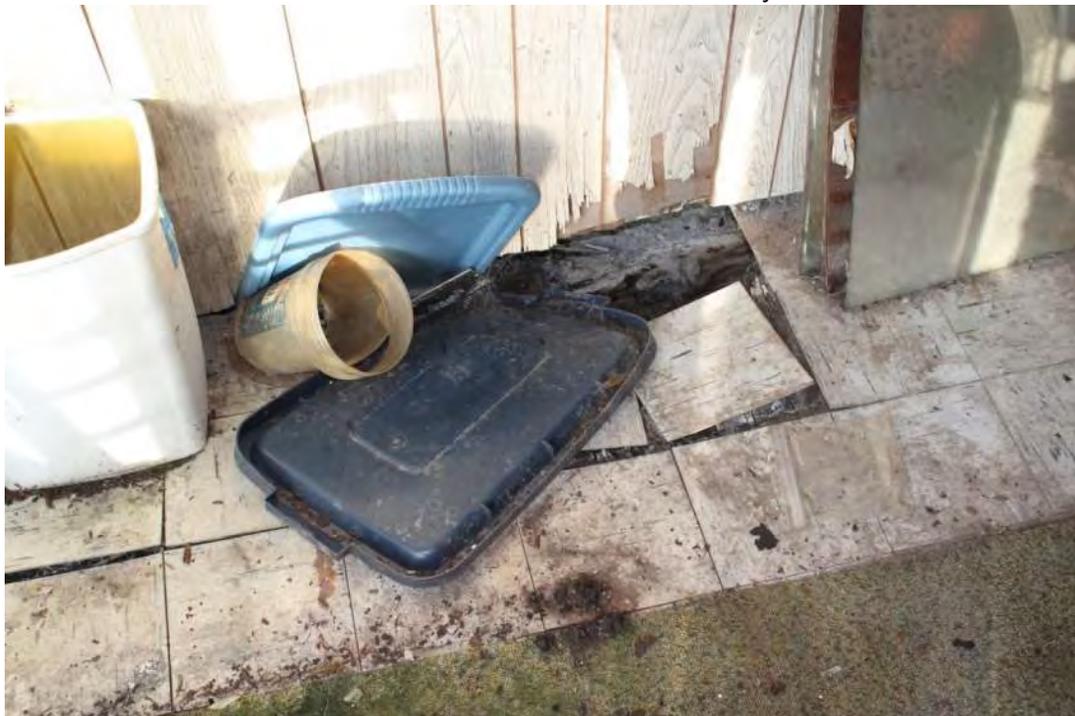
Photo 4 - View of asbestos-containing 9"x 9" white floor tile and associated black floor tile mastic
on the first floor.

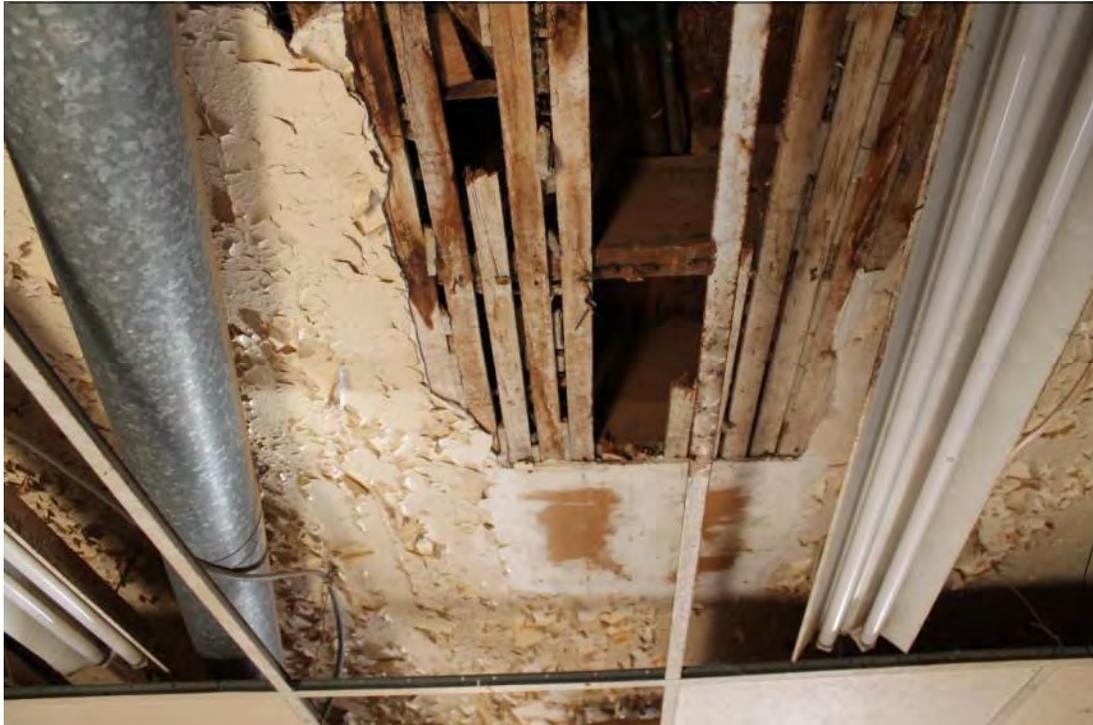
Photo 5 - View of asbestos-containing ceiling plaster skim coat on the first floor workshop area.

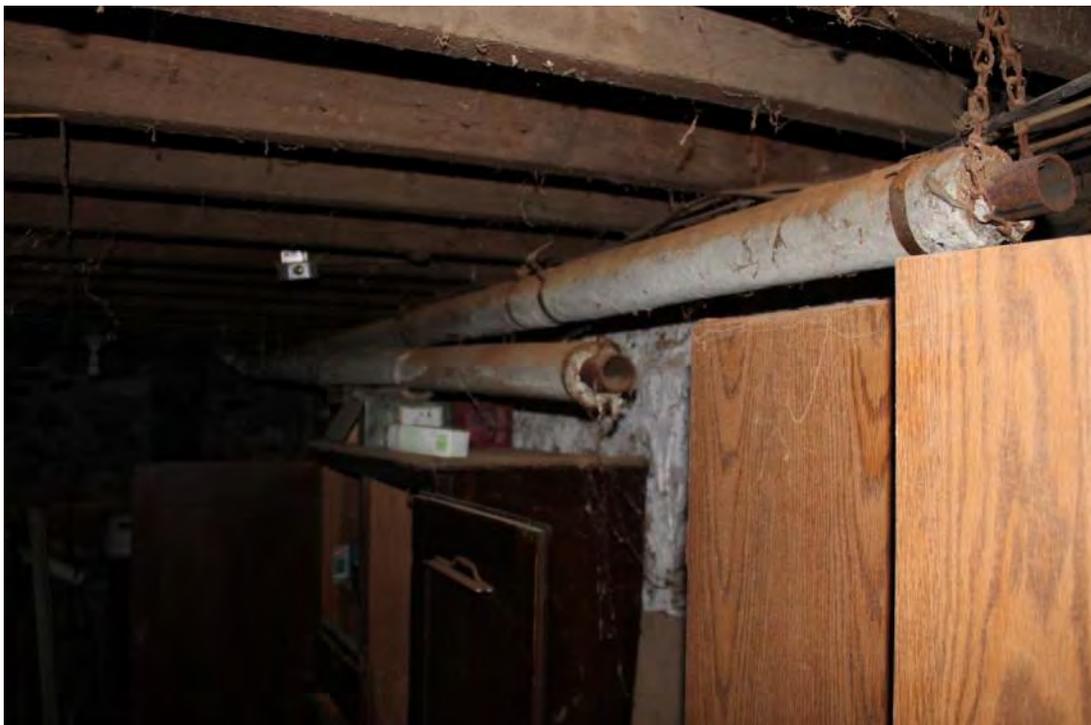
Photo 6 - View of asbestos-containing pipe insulation in the basement. Assumed present in wall cavities on the first floor.

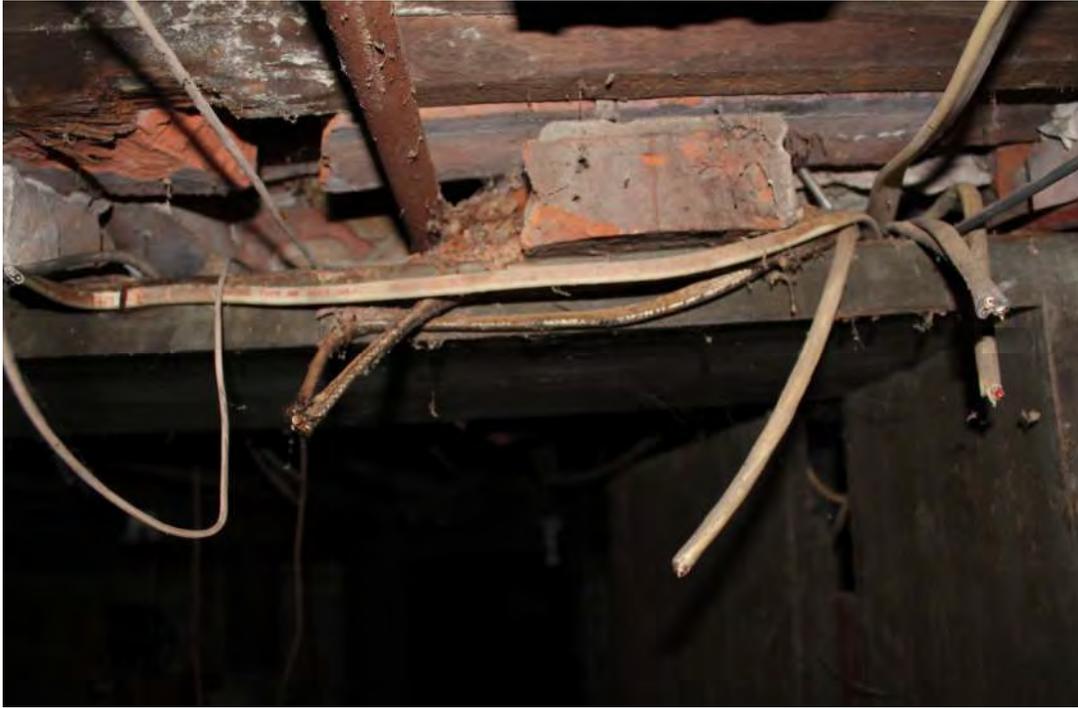
Photo 7 - View of assumed asbestos-containing braided wire insulation in the basement.

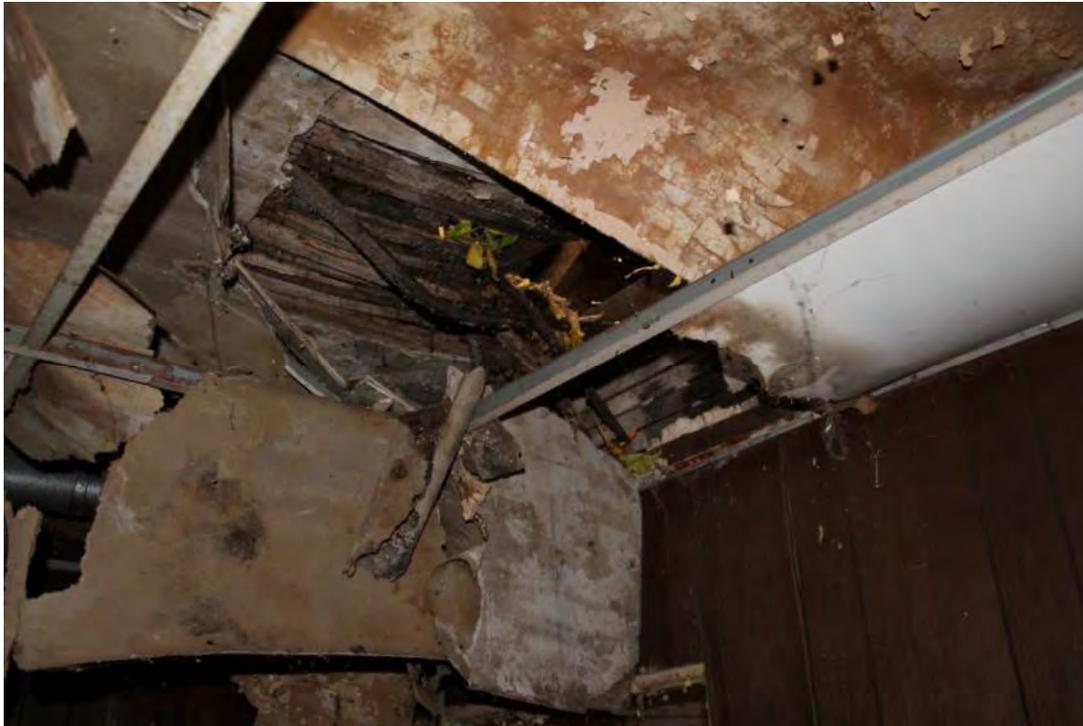
Photo 8 - View of wall panels with asbestos-containing mastic on the first floor.
Note: Dangerous site conditions, ceiling collapsed.

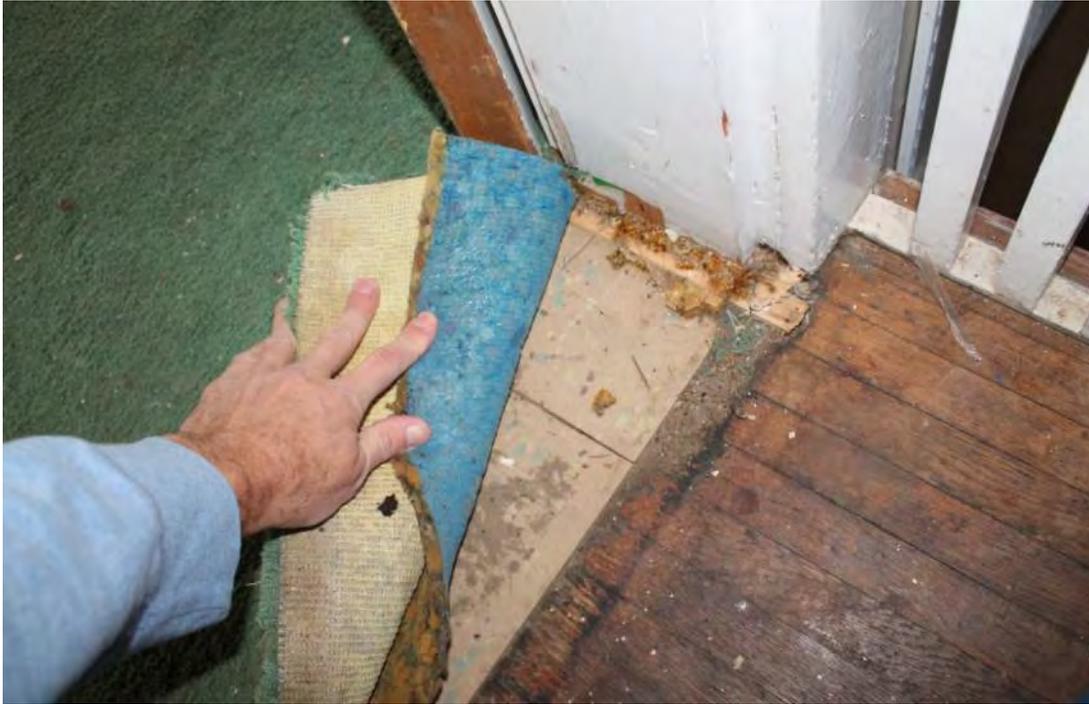
Photo 9 – View of asbestos containing 9 x 9 pink floor tile and associated black floor tile mastic under carpet in the second-floor apartment.

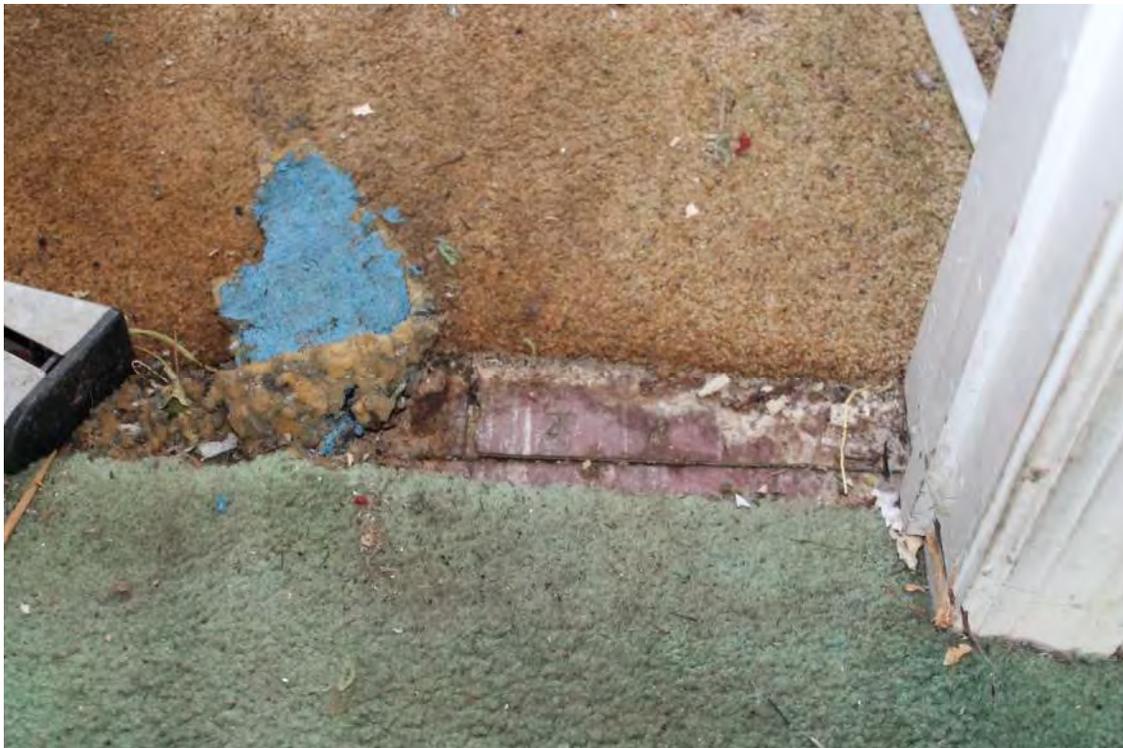
Photo 10 – View of asbestos containing 9 x 9 maroon floor tile and associated black floor tile mastic under carpet in the second-floor apartment.

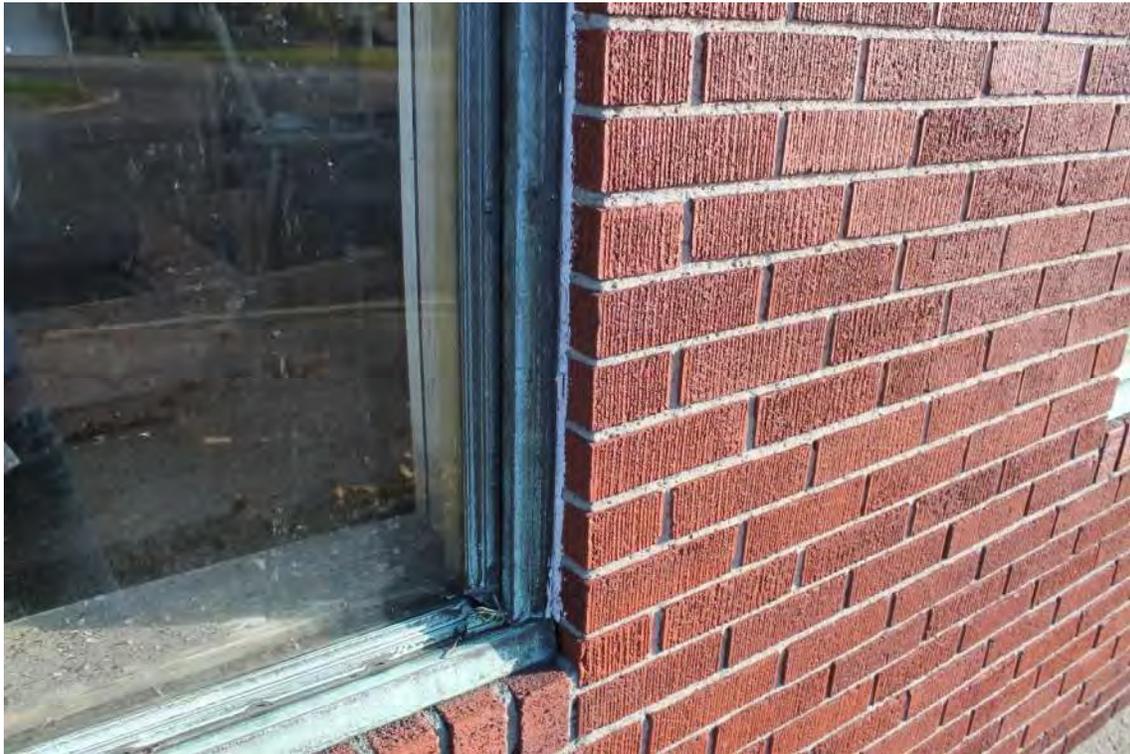
Photo 11 - View of asbestos containing window caulk copper frame to brick on the exterior storefront windows.

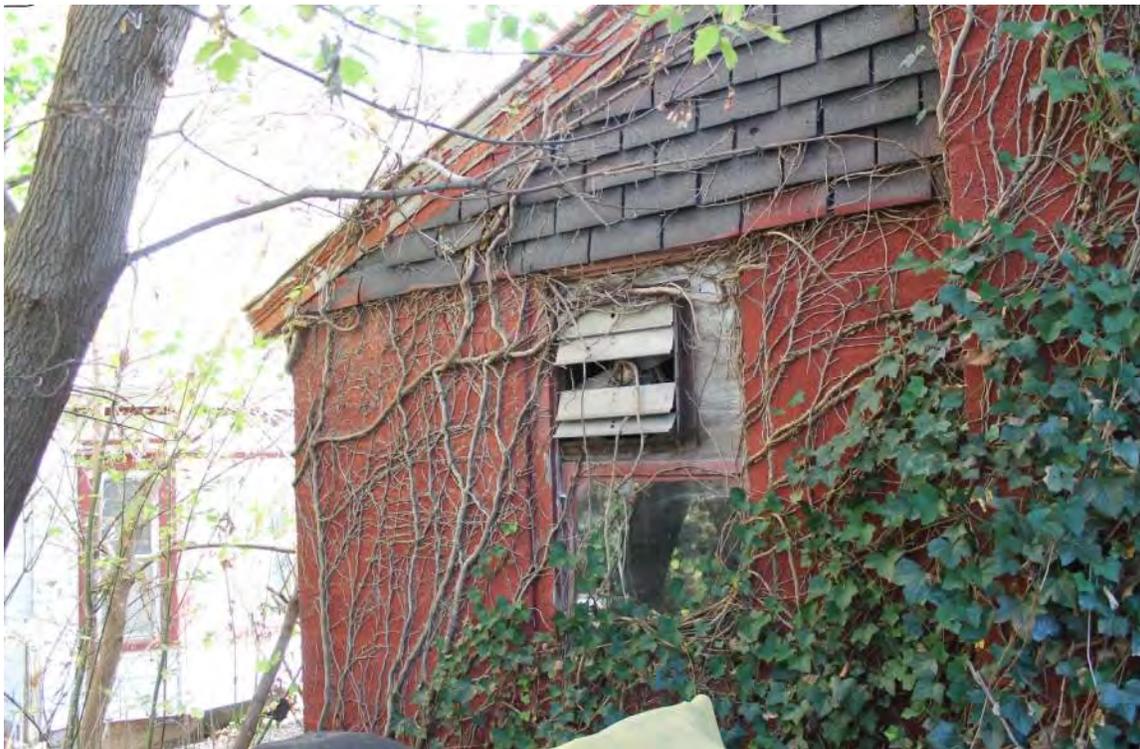
Photo 12 - View of asbestos containing window glazing compound on exterior garage window.

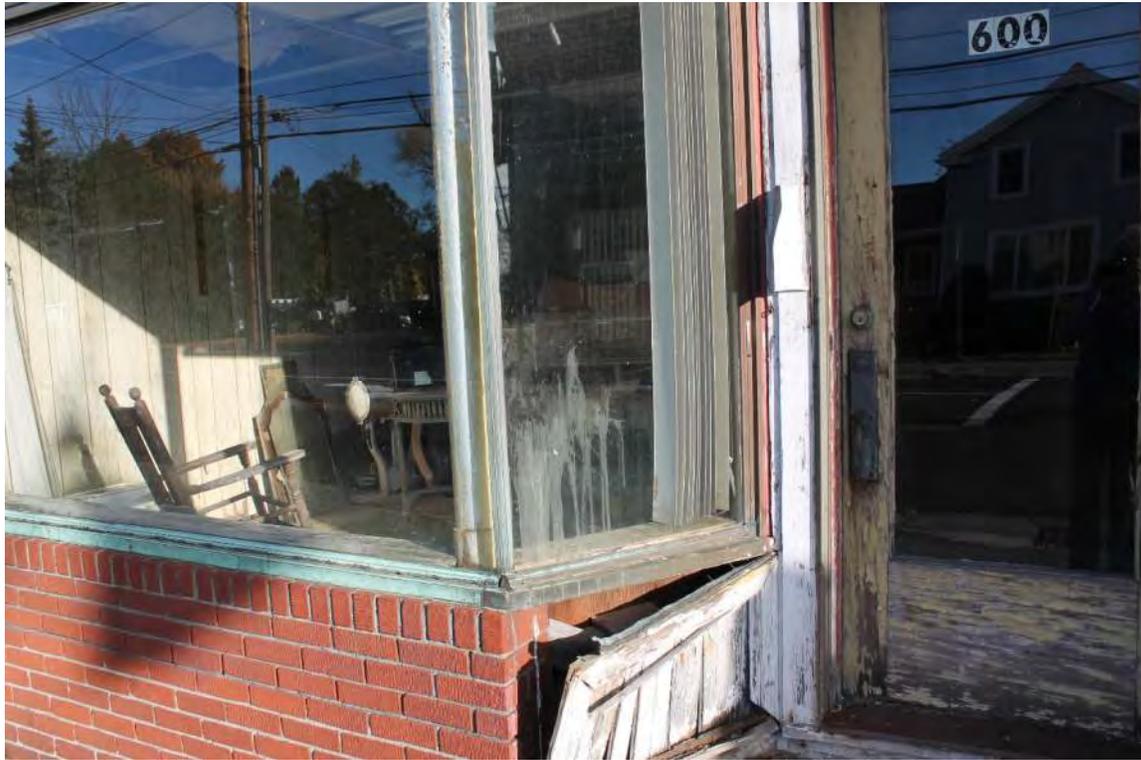
Photo 13 – View of asbestos containing window caulk on the copper window frame on the storefront windows, front of building.

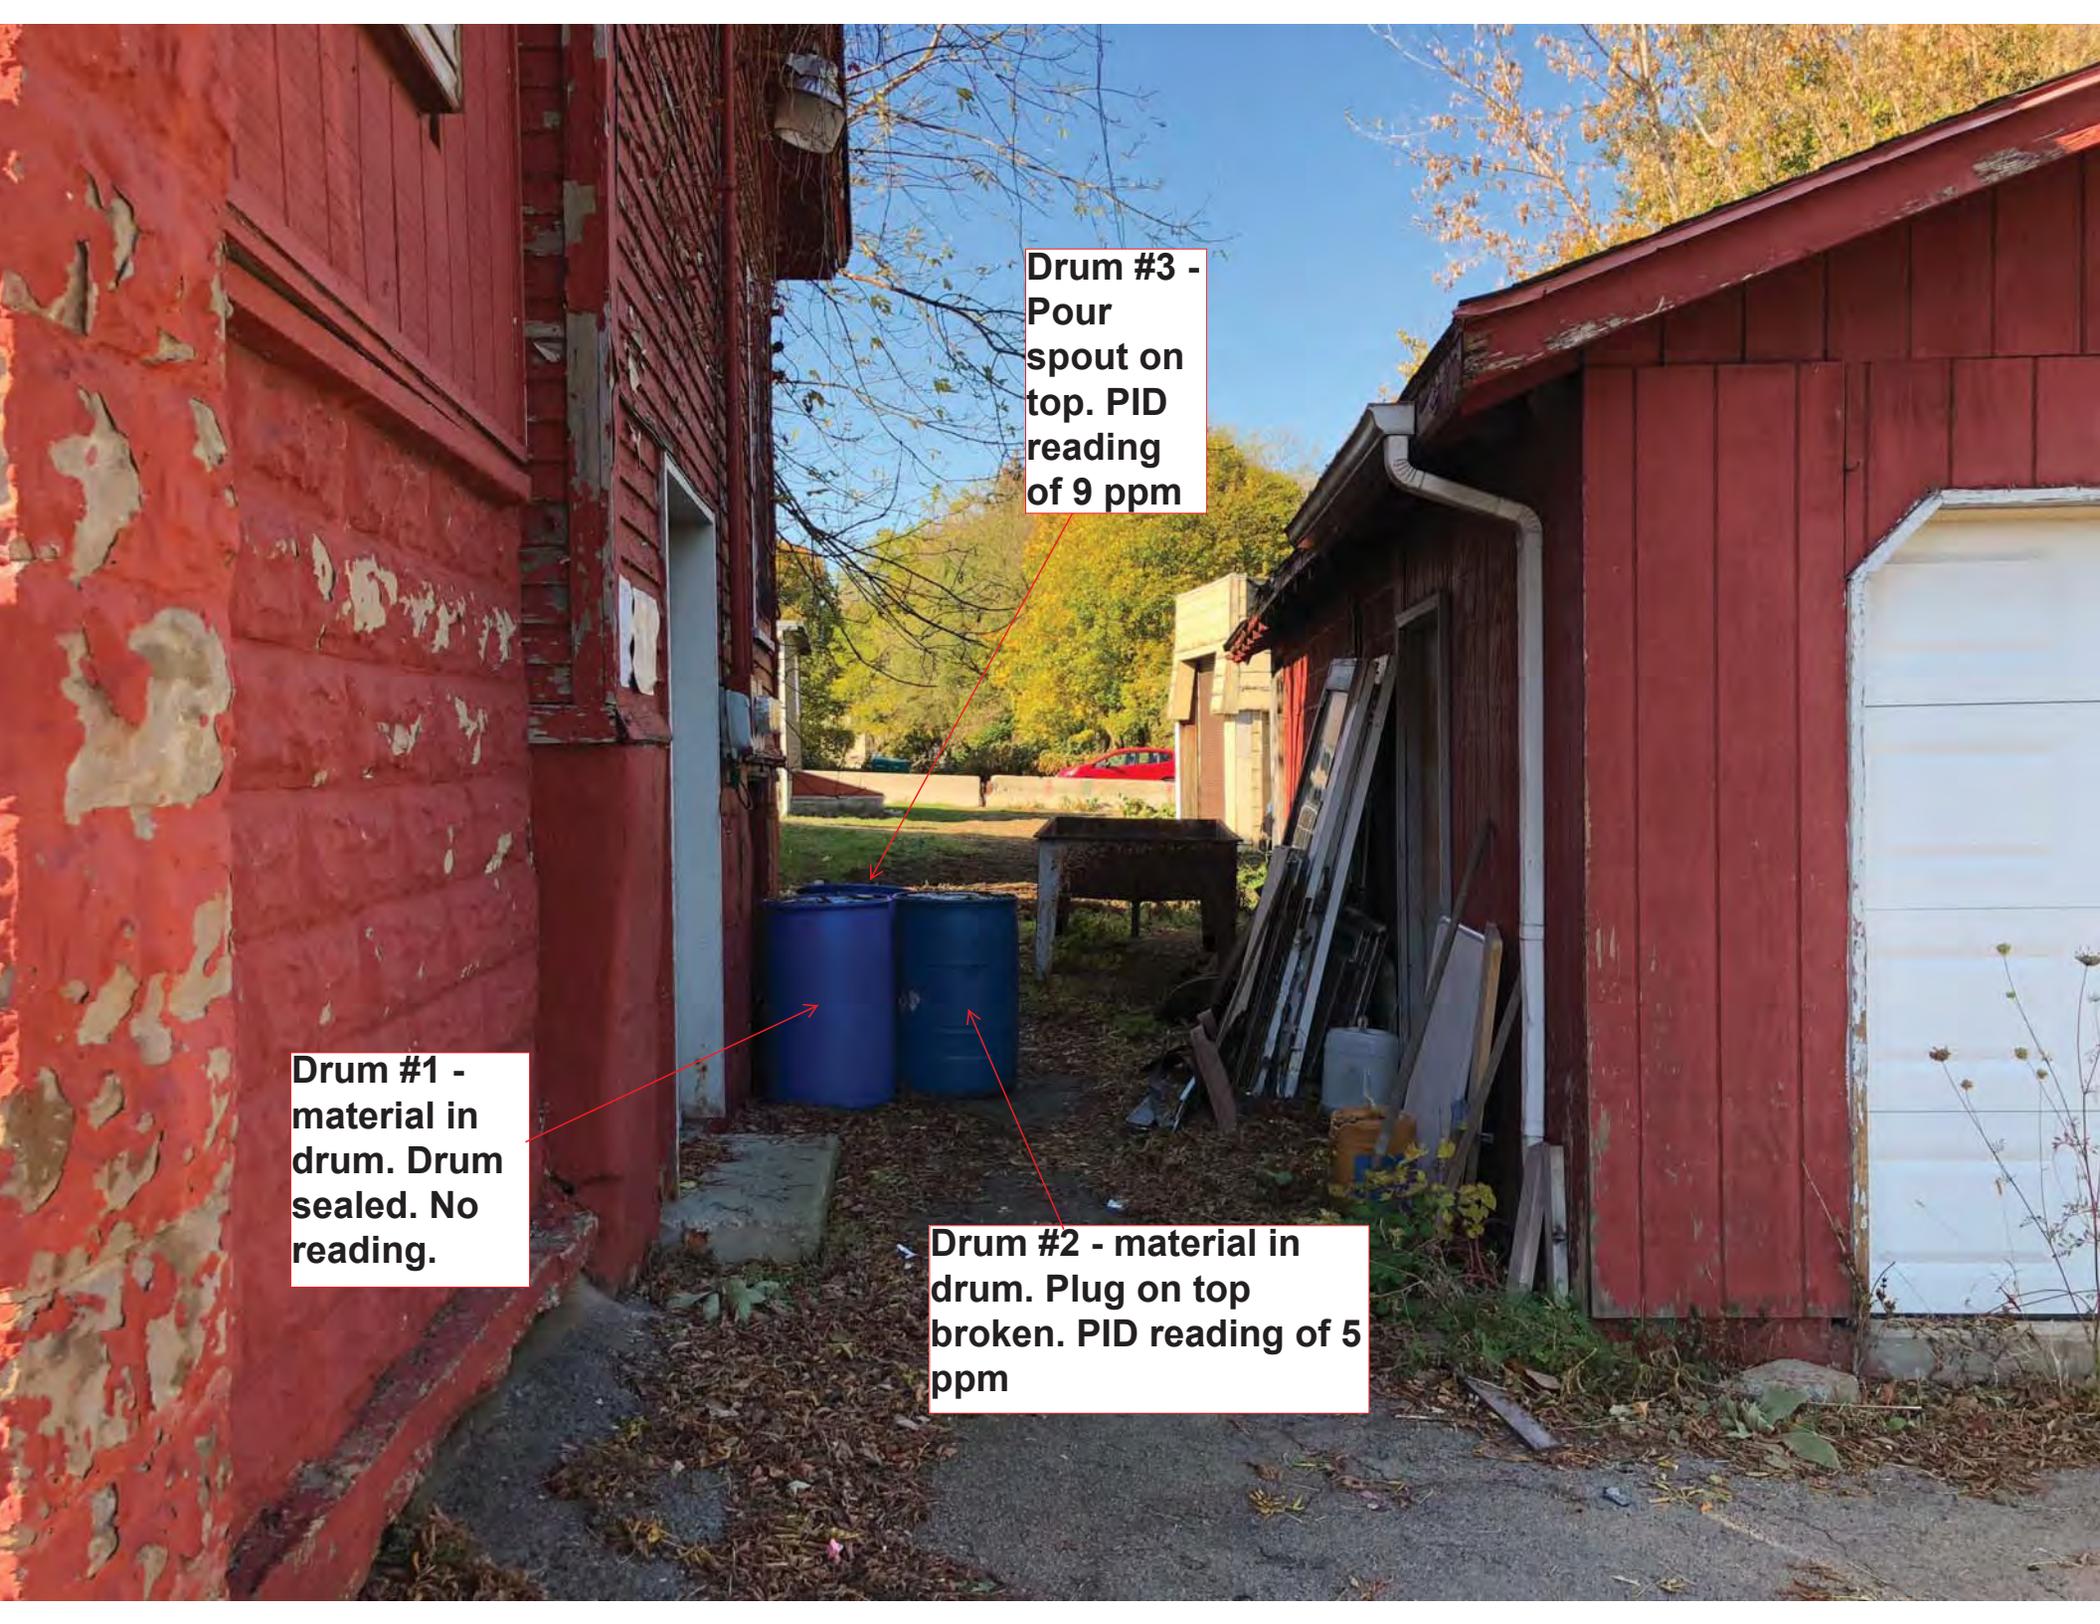
**Drum #1 -
material in
drum. Drum
sealed. No
reading.**

**Drum #2 - material in
drum. Plug on top
broken. PID reading of 5
ppm**

- Power to the building appears to be shut off.
- Drums were located outside the buildings (i.e., between the main building and garage). Two drums labeled “Wood Stripper 125 UN 2022” and “corrosive” that apparently contained material were identified. PID readings measured above these drums ranged from 0 ppm to 9 ppm. A container labeled “Kerosene” had liquid inside, however, no PID reading was measured above this container. A container with a worn label that included the words “methylene dichloride, methanol” and a skull and crossbones had liquid inside, but no PID reading was measured above this container.
- Debris (e.g., tires, tarps, scrap wood) was present outside the structures on the Site.
- Cans of paints and other chemicals were stored inside the garage building.

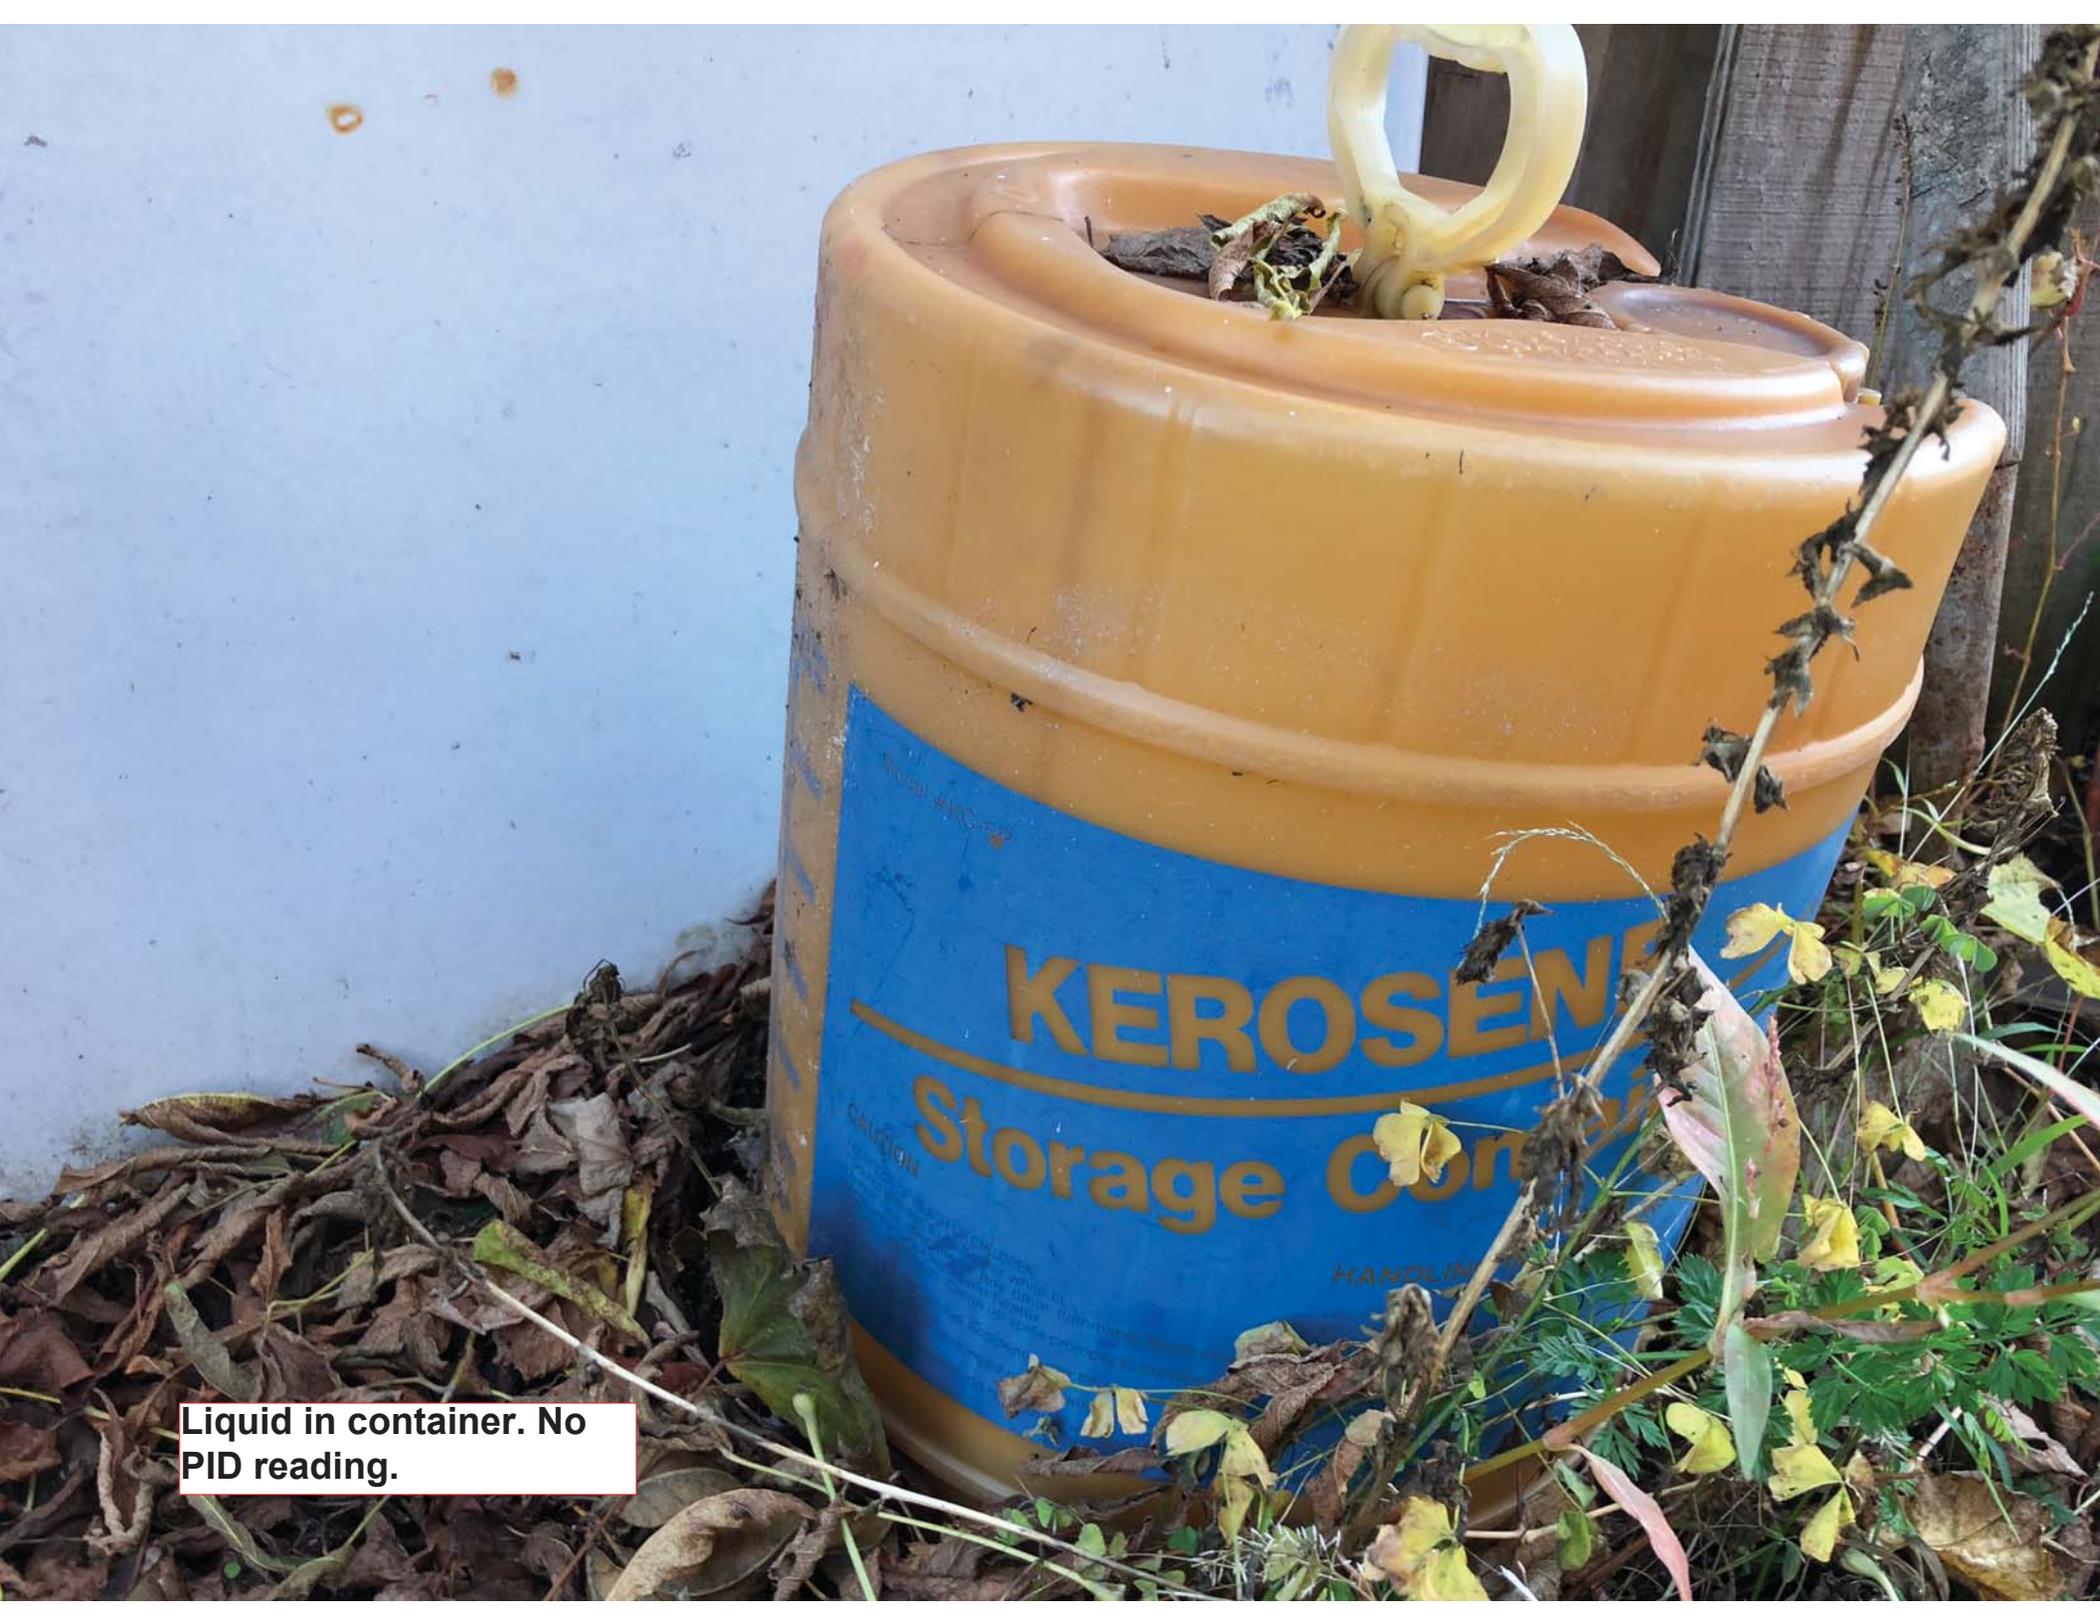
Liquid in container. No
PID reading.

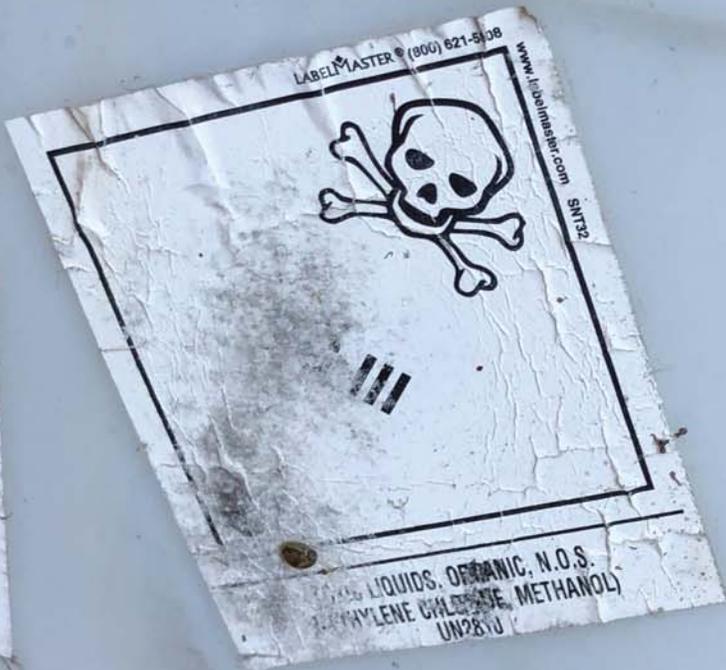
Liquid in container.
No PID reading.

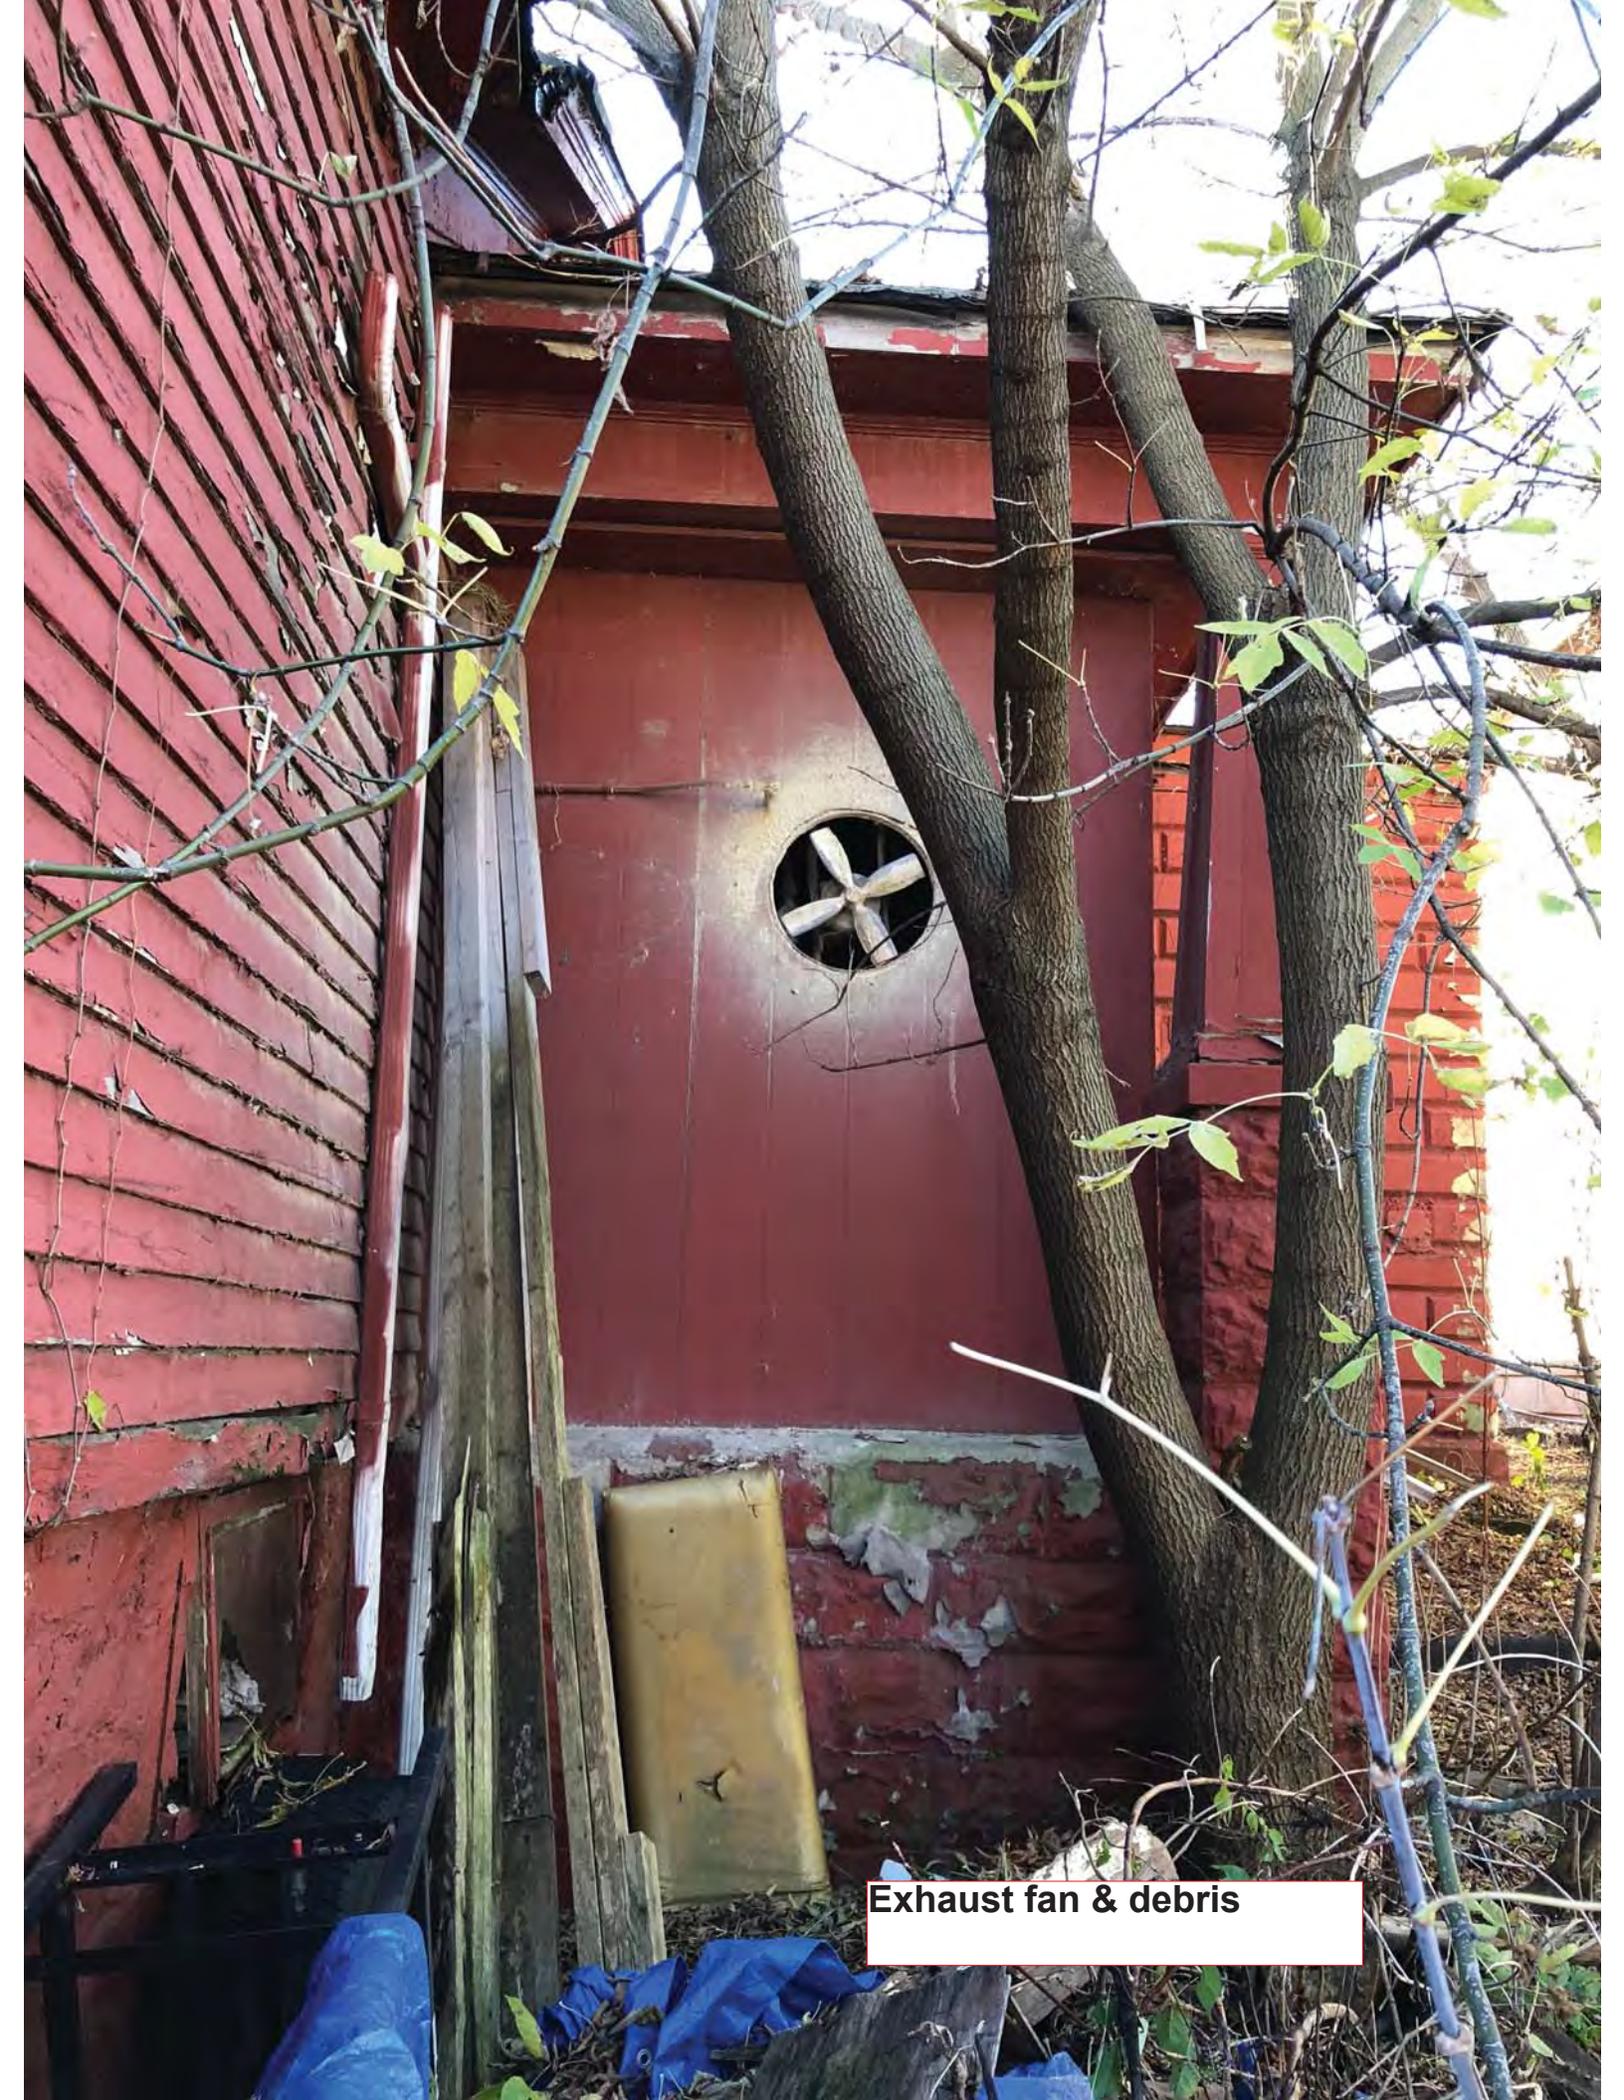
Exhaust fan & debris

- “I observed a large kennel complex at the rear of the property and noted a slight solvent-like odor. Ms. Kerson was not at home. The source of the odor appeared to be emanating from an exhaust fan on the north wall (east end) of the main building at Webster Furniture Stripping.”
