**PHASE II ENVIRONMENTAL SITE ASSESSMENT
And
REGULATED BUILDING MATERIALS SURVEY**

**600 Ridge Road
Webster, New York**

Project No.: 5930S-22 / 22-3624S

Date: December 20, 2022
(Revised January 3, 2023 and January 27,
2023)

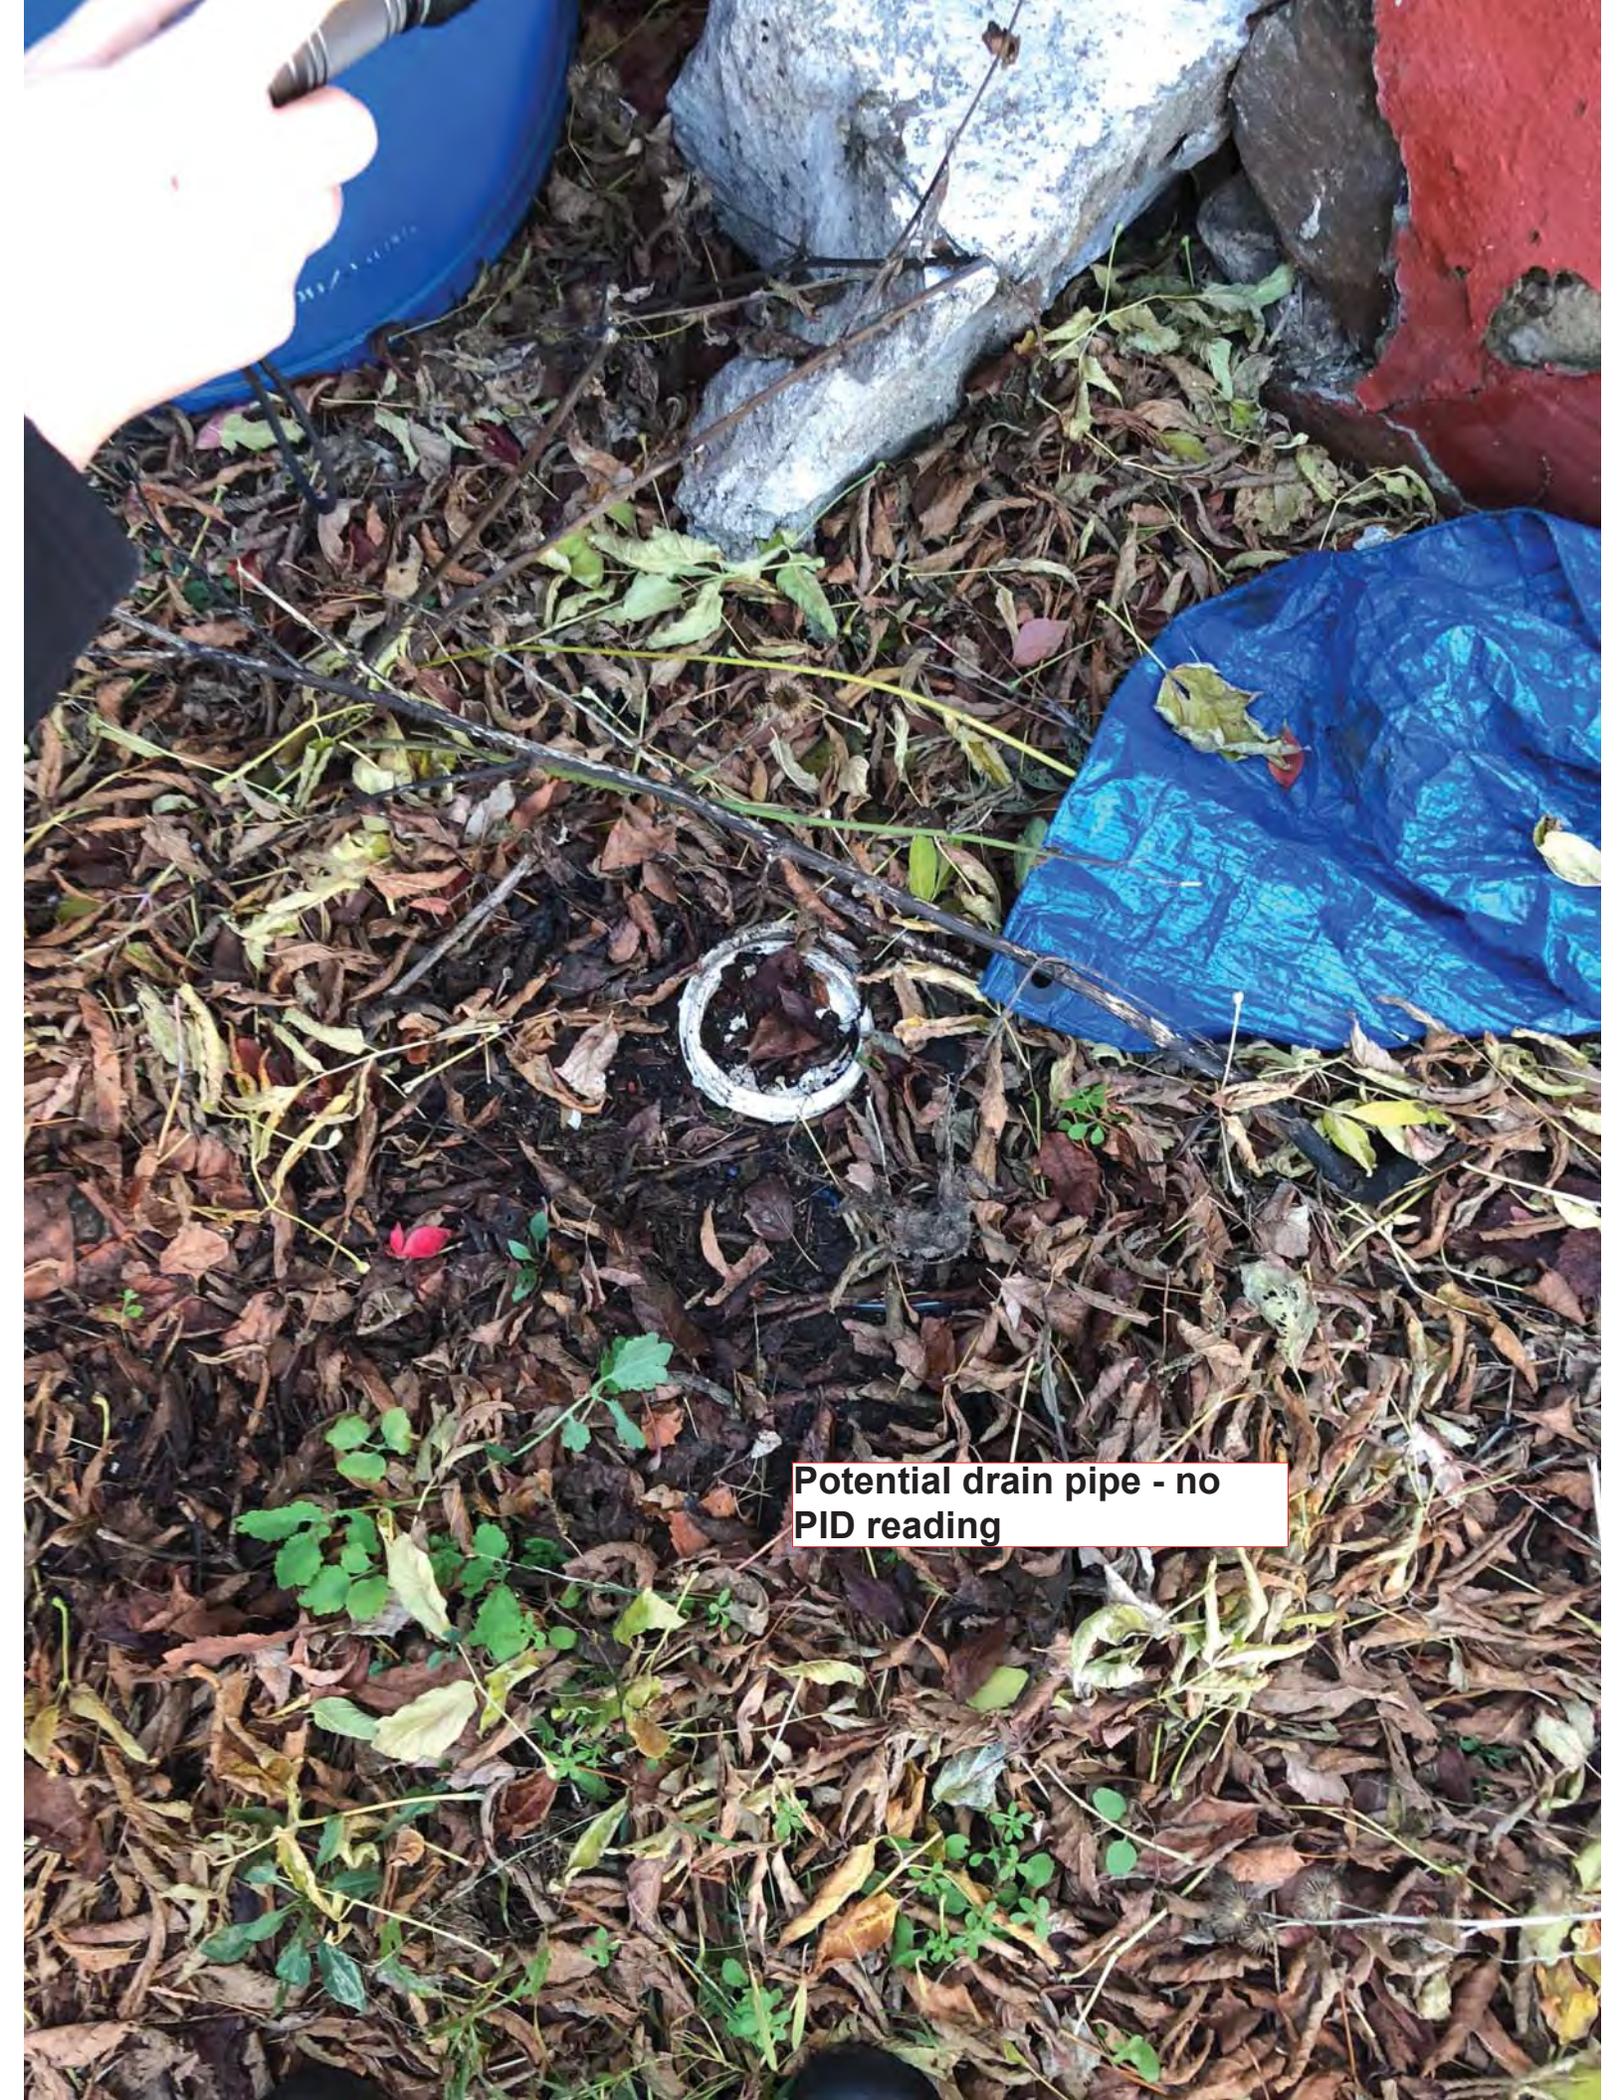
Potential drain pipe - no
PID reading

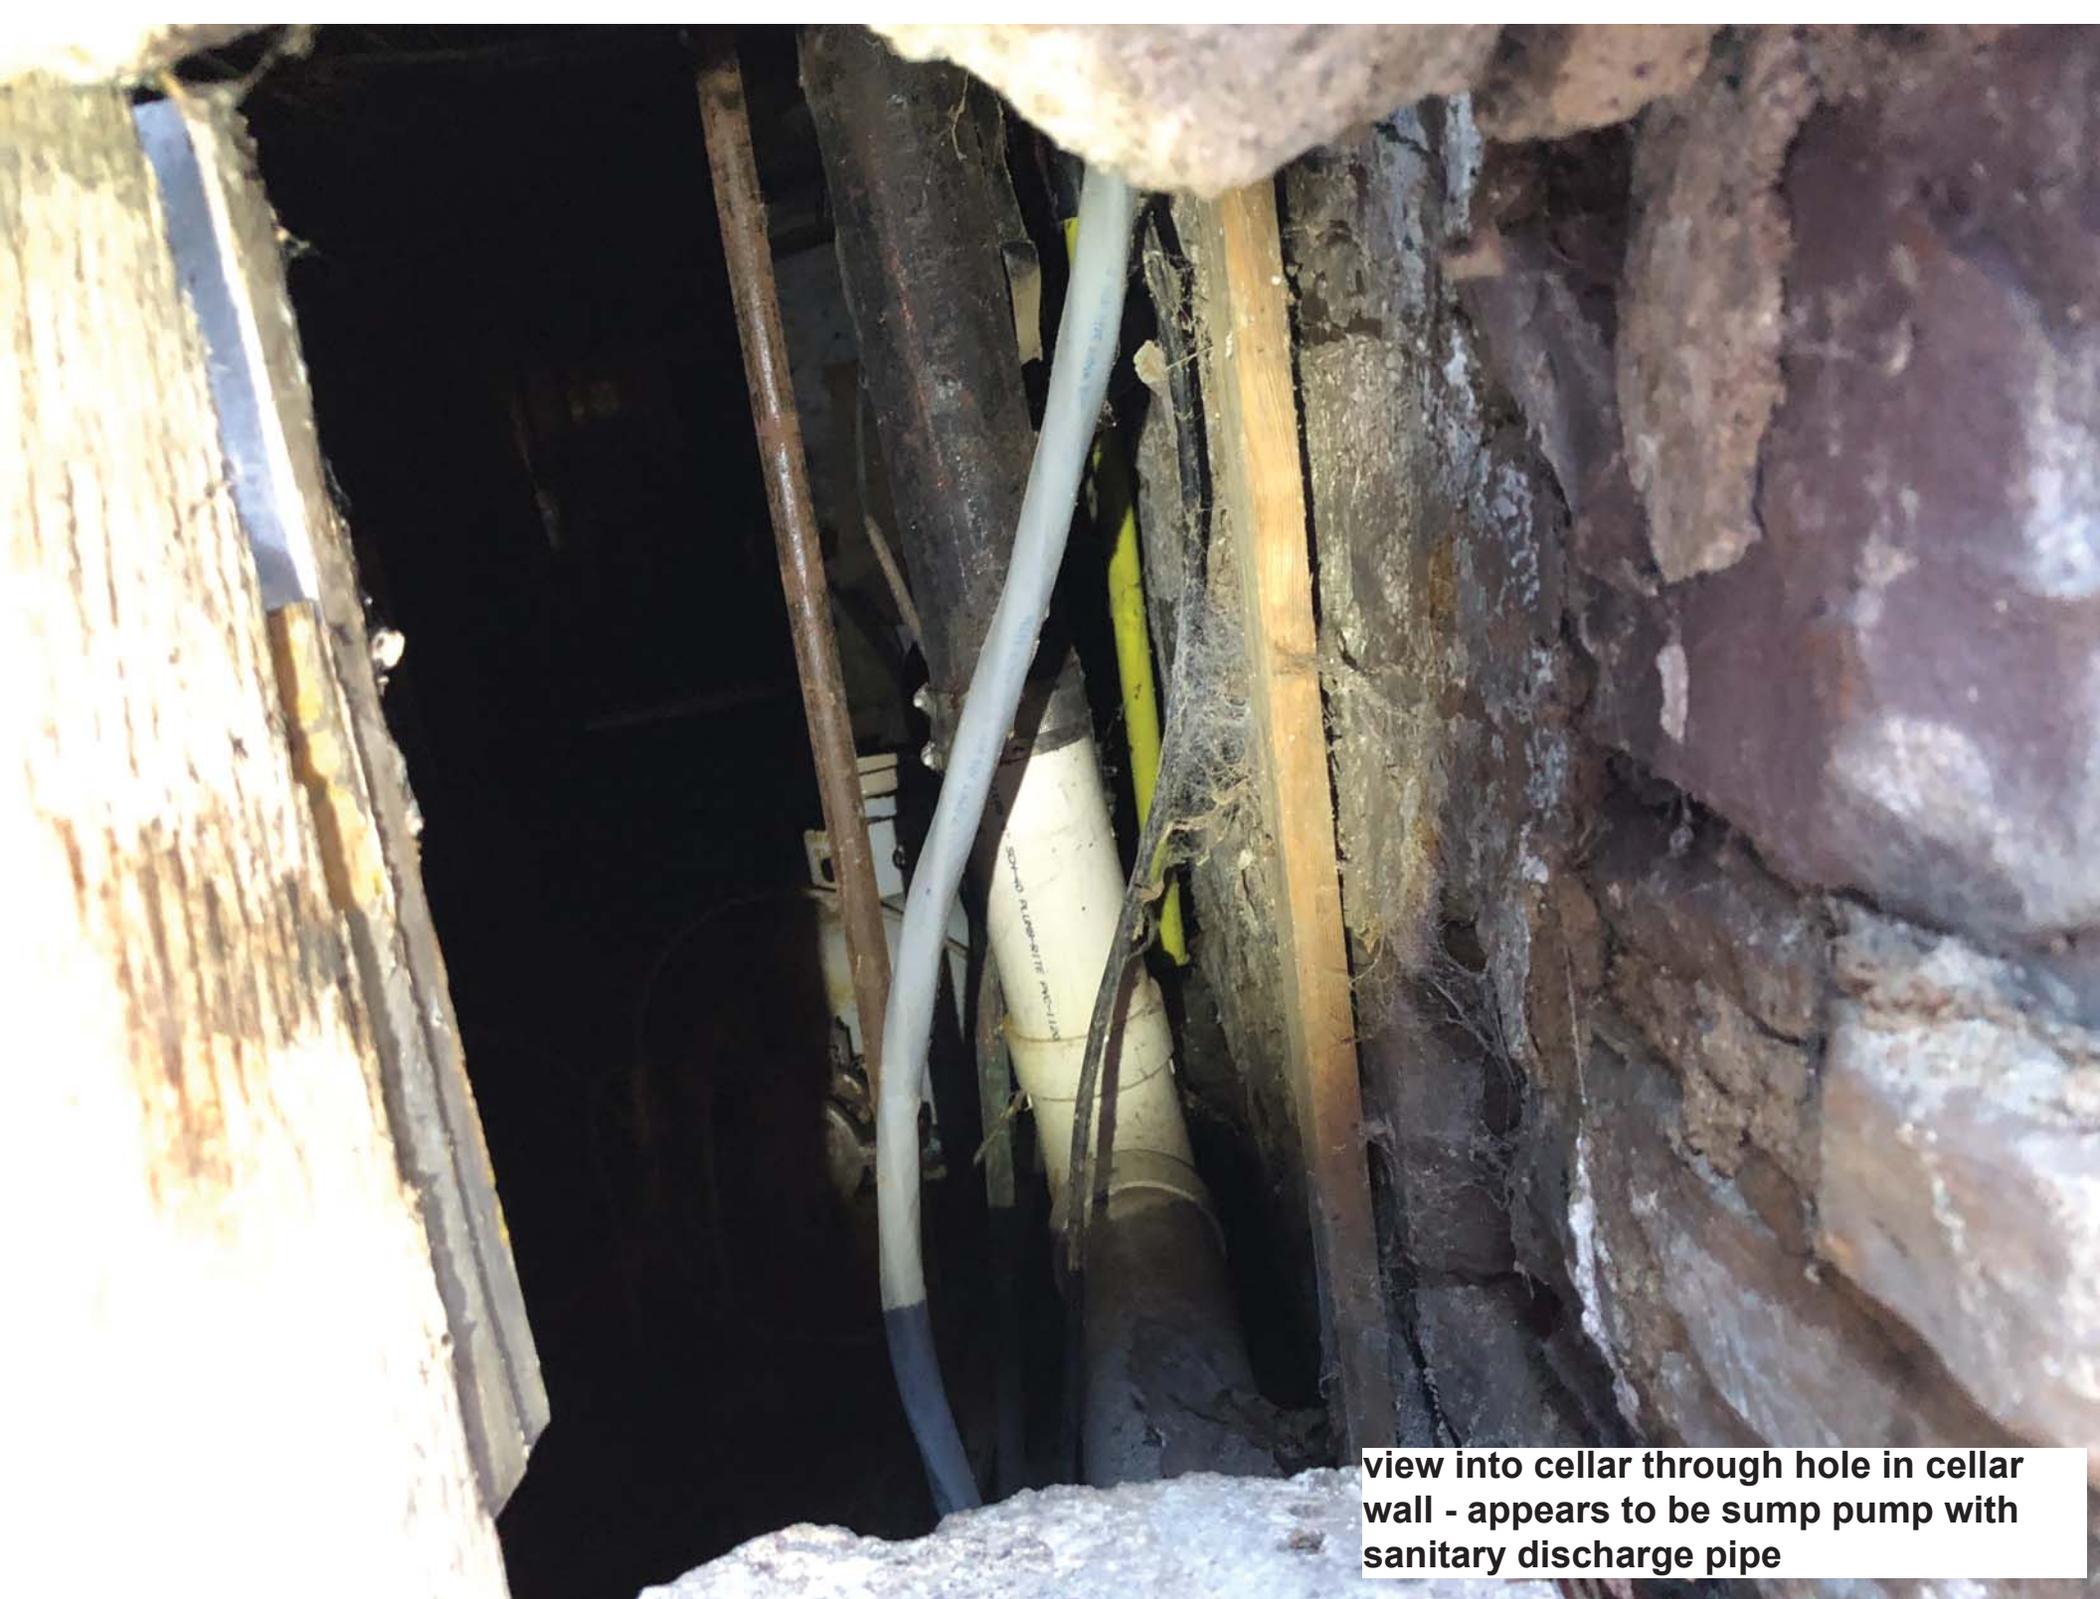
view into cellar through hole in cellar wall - appears to be sump pump with sanitary discharge pipe

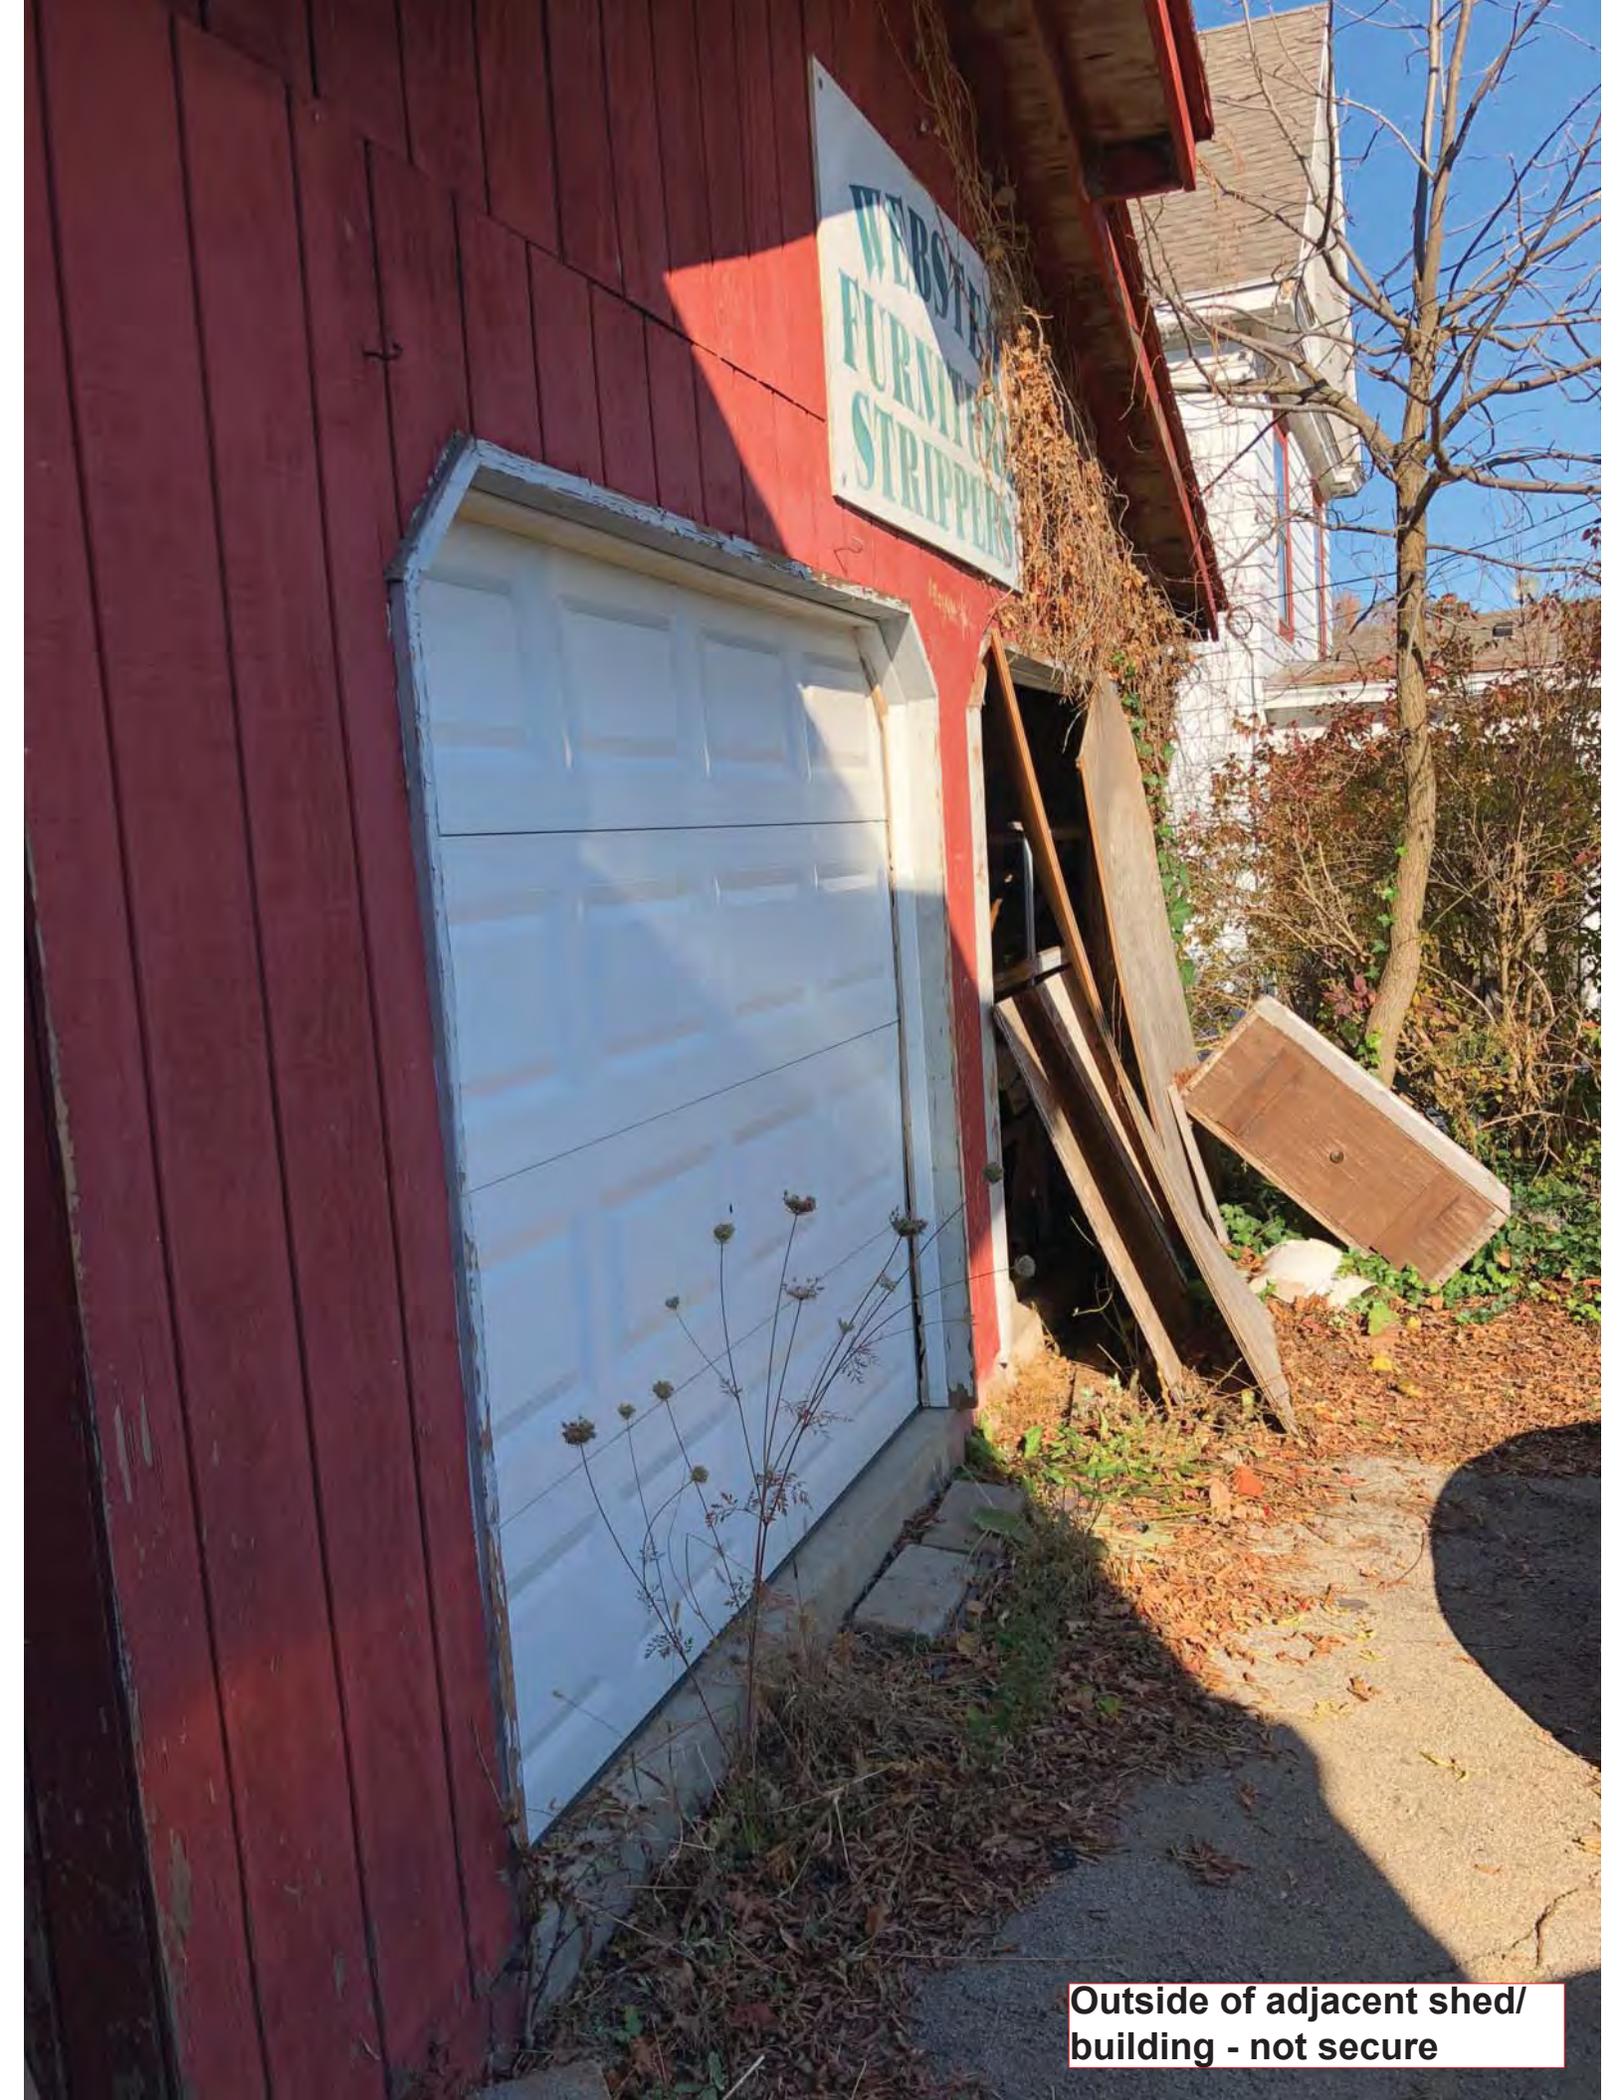
**Outside of adjacent shed/
building - not secure**
