# Structural Assessment Report

600 Ridge Road  
Webster, NY 14580

December 13, 2022

Report Prepared for:  
Town of Webster

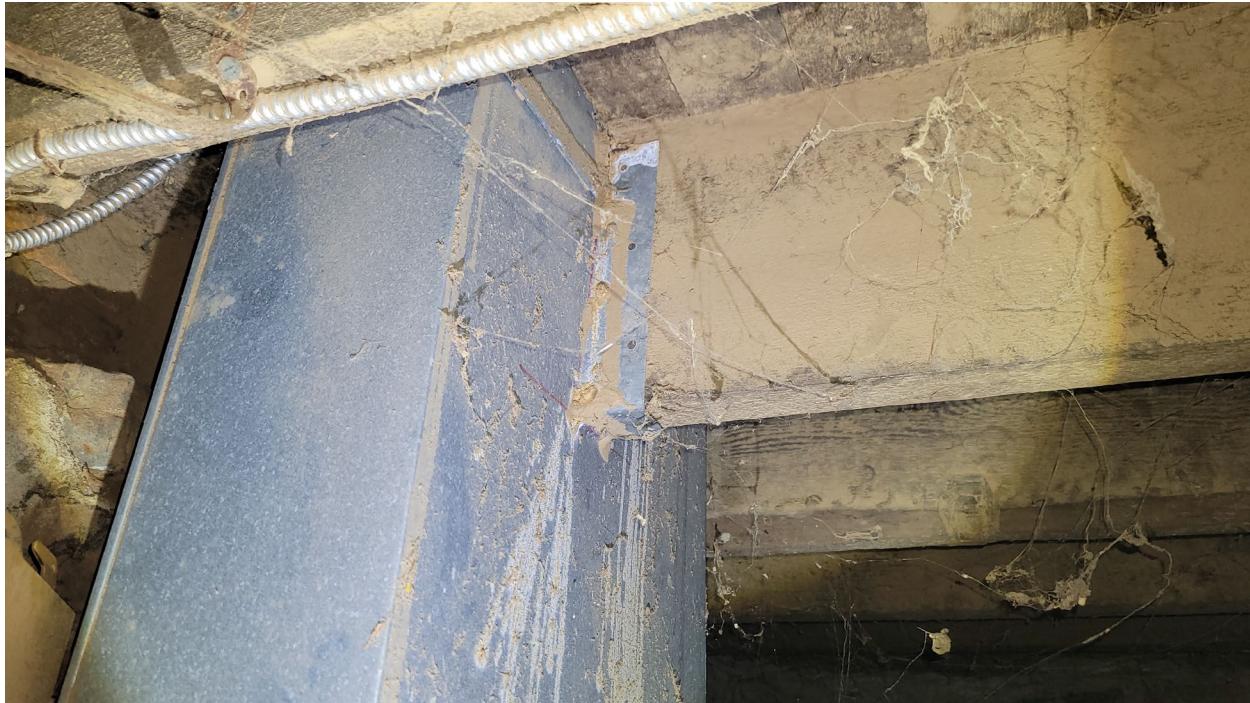
*Photo 13: See photo 12.*

14. Photo 12: Reroute ductwork around joists, or install a header to support the joist. Remove joist hangers from duct work. Do not bear joists on ductwork.

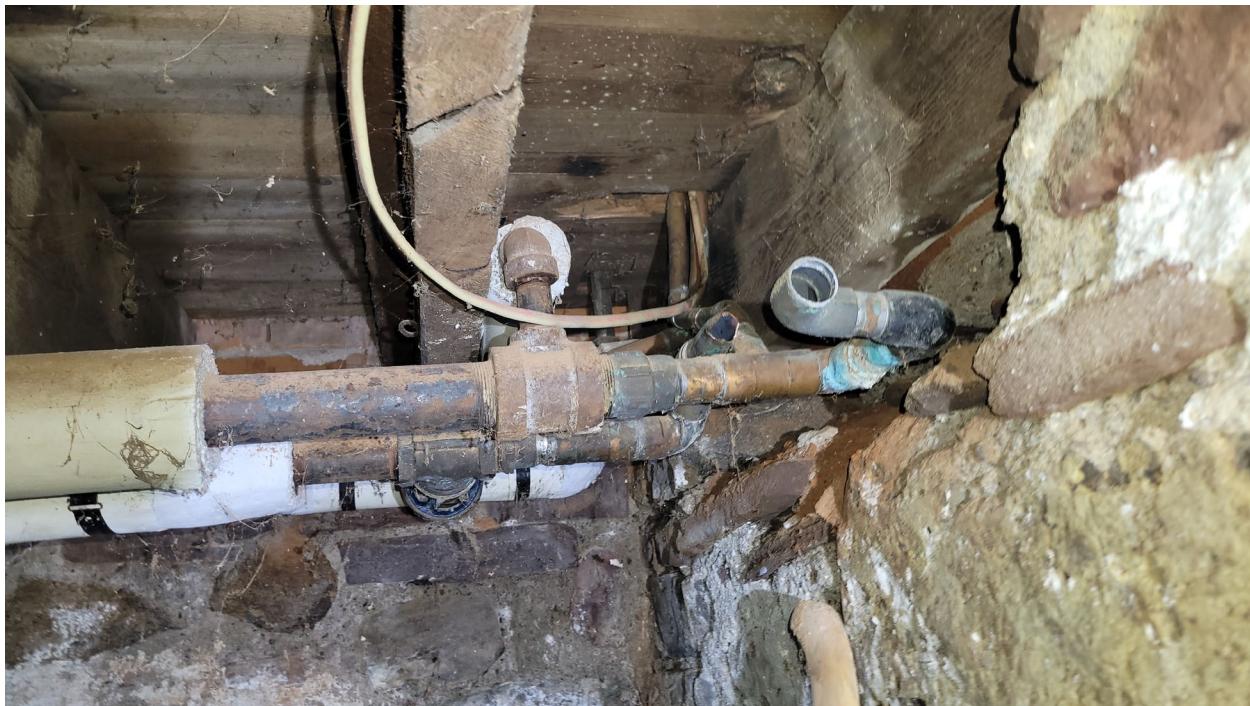
20. Photo 54: Water main location is in the south east corner of the building (near intersection of Ridge Road and Gravel Road)
21. Photo 55: Cap or remove all abandoned piping.

*Photo 54: Water main location is in the south east corner of the building (near intersection of Ridge Road and Gravel Road)*

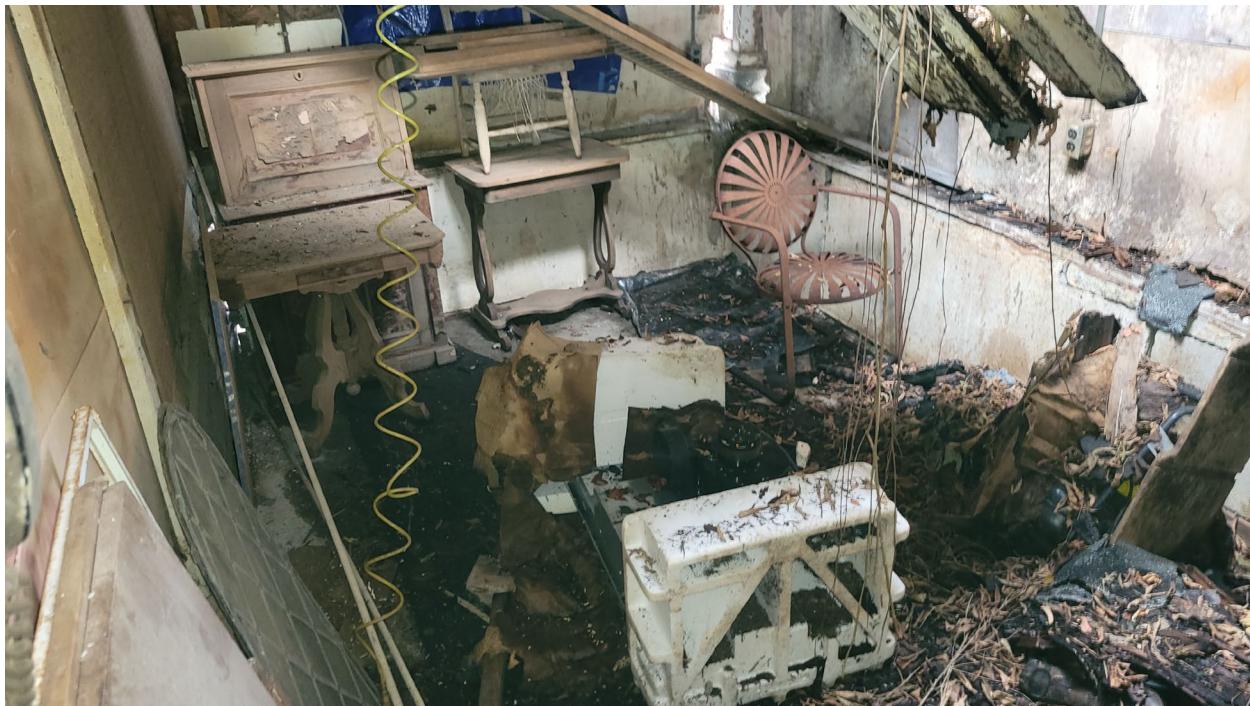
22. Photo 57: Area 5, needs extensive repair work done to foundation. See Note 7
23. Photo 62: Collapsed roof of Area 3.
24. Photo 72: Remove all fallen or delaminated ceiling panels.

*Photo 62: Collapsed roof of Area 3.*

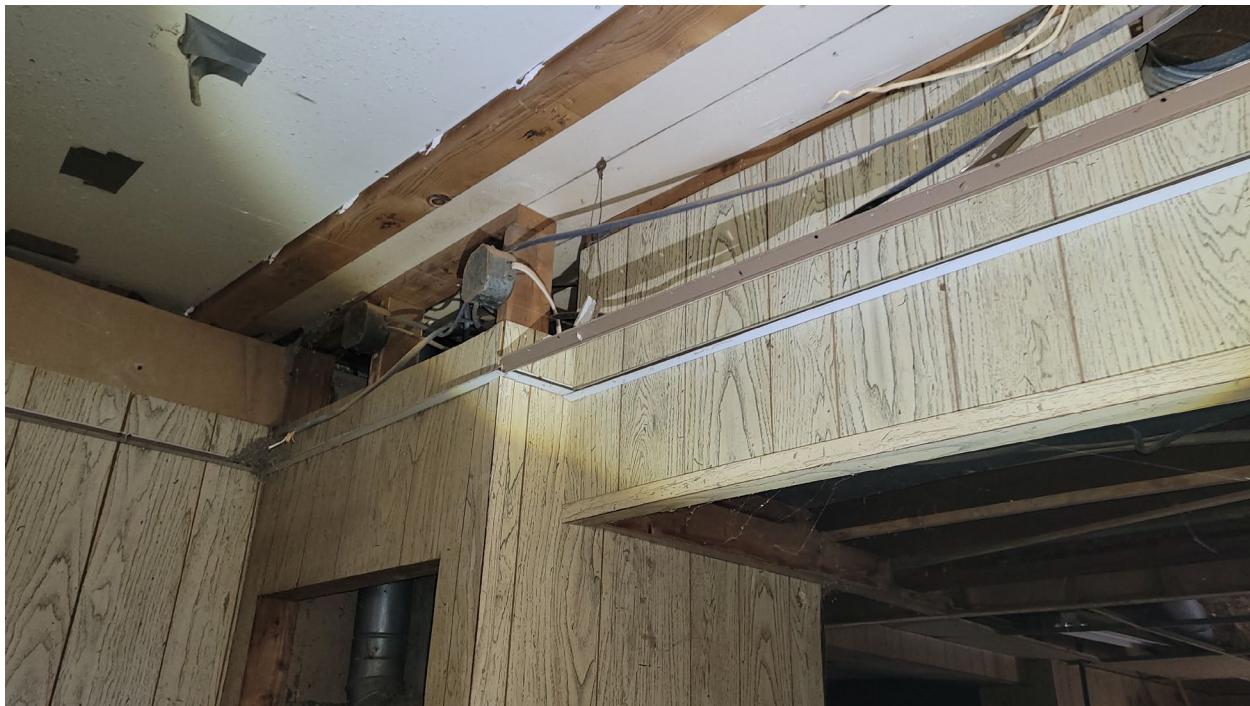
*Photo 93:*

9. All observable framing in the basement appeared to be in serviceable condition and structurally sound with exception of area 5 (noted in #7).
10. The floors on the first floor need to be repaired in multiple areas (see photo 93).

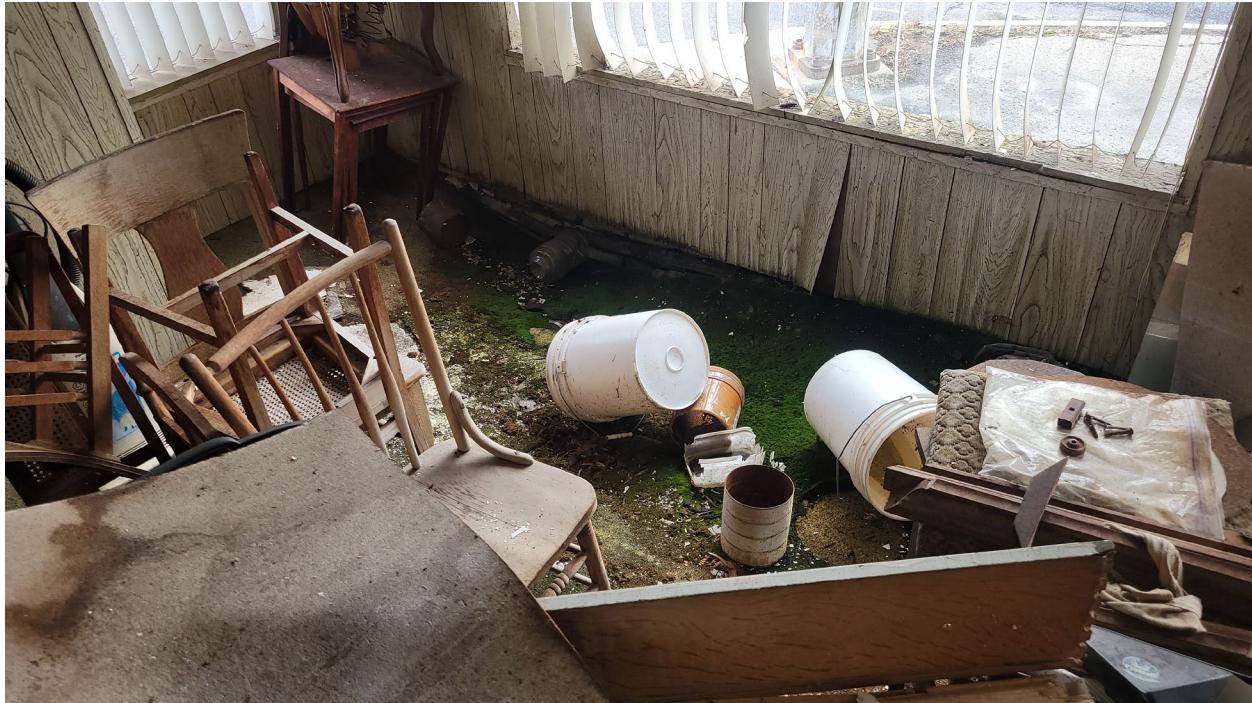
2. There are 5 areas of the existing structure that need to be repaired. See attached drawing.
3. Area 1 – The floor has collapsed in this area. The existing collapsed joists need to be removed and replaced in kind with new 2x framing @ 16" o.c. Subfloor thickness to match existing. Screw to new joists with #8 screws @ 16" o.c. Joists to bear on existing sill plate and toenailed into rim joist or sill plate. Install blocking at midspan. Total area of replacement is about 50 sq. ft.

27. Photo 104: Area 1. See note 3.
28. Photo 113: Repoint all existing brick
29. Photo 116: Remove and replace all existing ceiling lathe that is water damaged.

*Photo 104: Area 1. See note 3.*

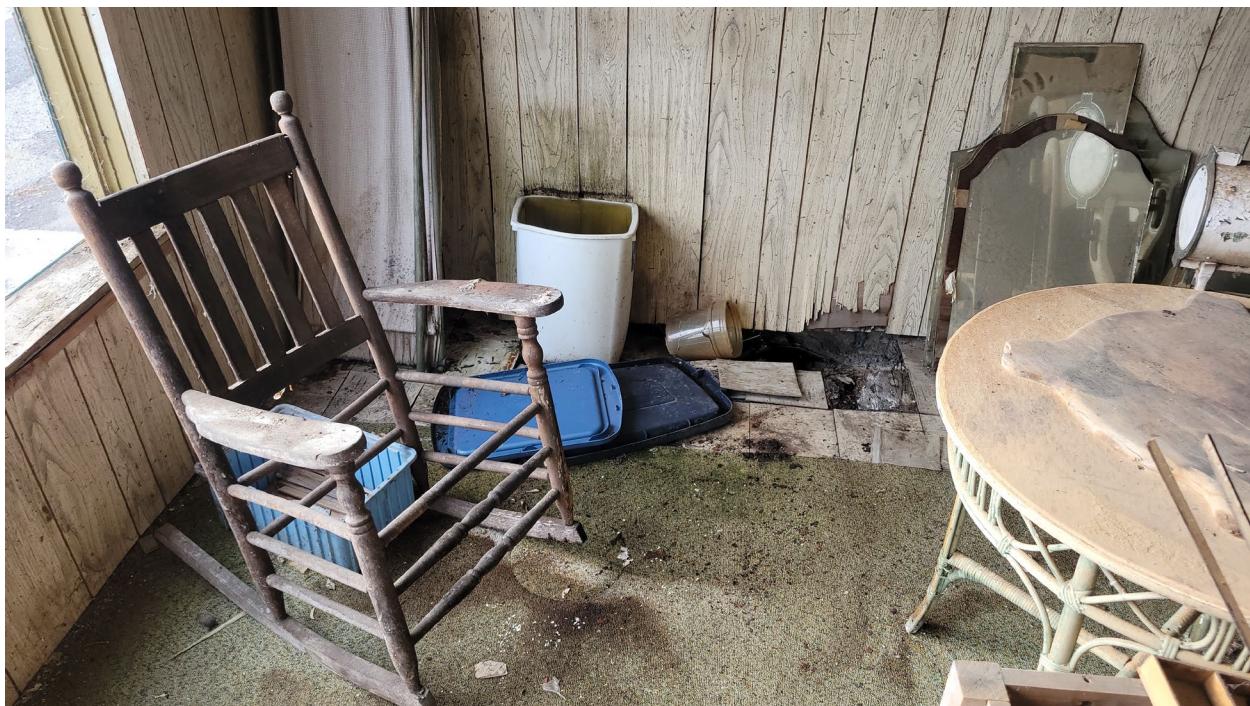
32. Photo 121: Area 3 roof.
33. Photo 140: Area 4 roof.
34. Photo 142: Area 3 roof.
35. Photo 144: Area 2, see note 4.
36. Photo 145: Steel lintel needs to be replaced, see note 8.

*Photo 144: Area 2, see note 4.*

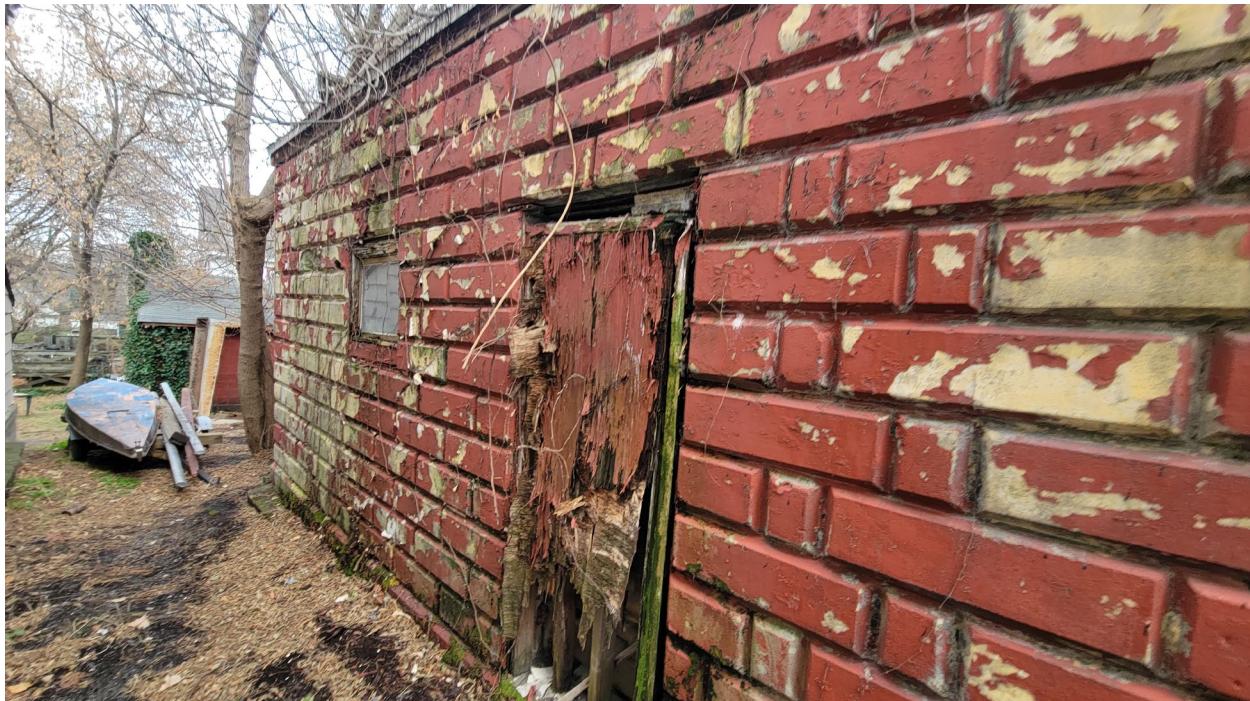
*Photo 152: Remove all rotted wood from exterior and infill opening to be watertight.*

37. Photo 152: Remove all rotted wood from exterior and infill opening to be watertight.
38. Photo 155: Recommended to replace window with glass block.
39. Photo 156: Repoint face of exterior block to prevent moisture degradation.

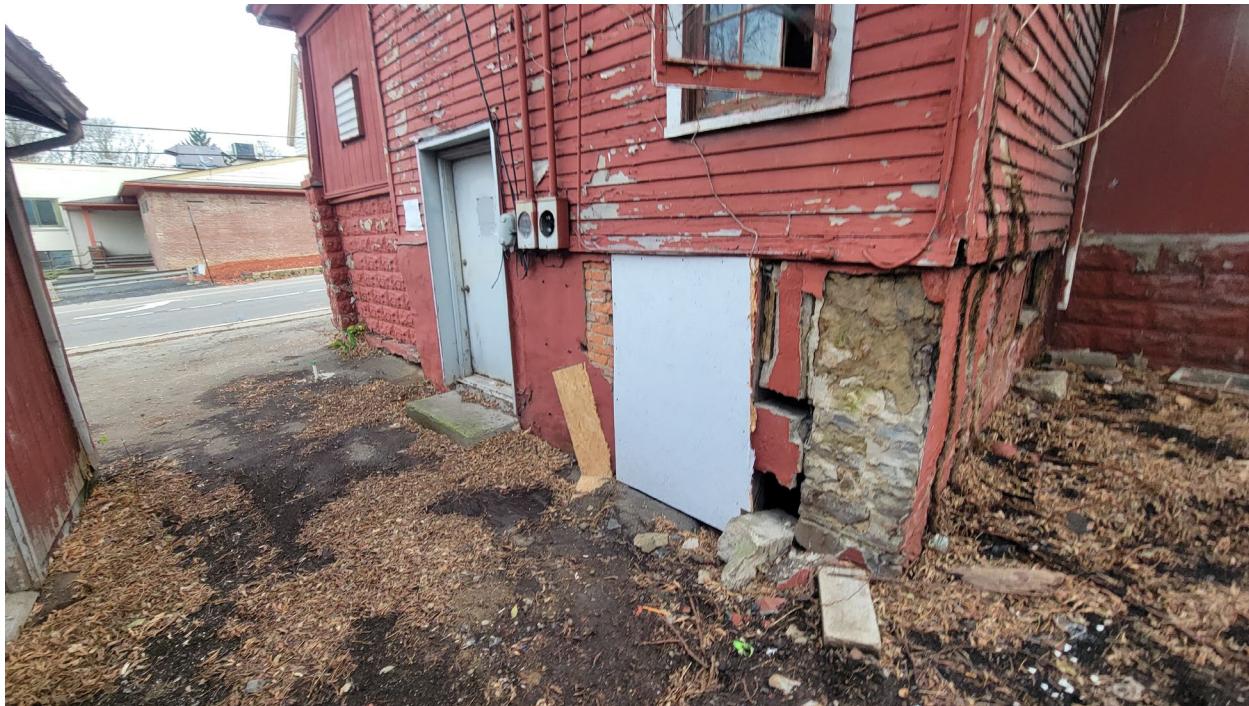
42. Photo 165: Area 5, see note 7.
43. Photo 168: Evidence of settlement. It is recommended to seal the cracks with a non-shrink grout and then seal the face of the crack lines with an epoxy sealant. Monitor if there is any crack propagation over the next 6 months. If cracks return, contact the Engineer (Grefrath, 716-491-0019) for reinforcement recommendations.

*Photo 165: Area 5, see note 7.*
